- 1.1. This statement of work (SOW) describes the services and deliverables required for the provisions of hazardous materials abatement for the Department of National Defence.

- 2.1. Supply all materials, labour, transportation and supervision at thirteen (13) steam vaults requiring Asbestos Containing Materials (ACM's) abatement. Scope of Asbestos Containing Materials (ACM) to be abated are in Appendix A. Notes on davit arm bracket condition status are also included in Appendix A for each steam vault. The professional engineer "Davit arm mounting plates Inspection" letter report by KNACO Design & Construction Ltd, dated December 27, 2022, can be provided to the Contractor after award, upon request.

- 2.2. Steam vaults requiring asbestos abatement:
1. H11
 2. H64
 3. H124
 4. H171
 5. H178
 6. H178B
 7. H183
 8. H300
 9. H478
 10. H855
 11. H903A
 12. H918
 13. H923

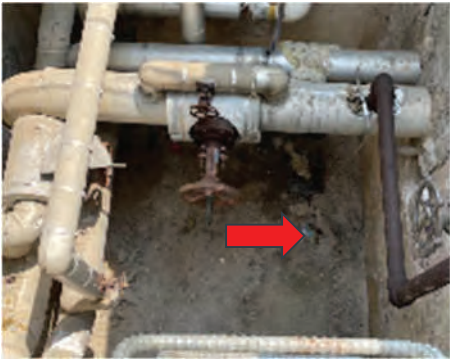
Photo	9	10

Sample ID	H918-08 A	H918-09 A
Material Description	Asbestos-containing debris in manhole H918	Asbestos-containing yellow insulation in manhole H918
Photo	11	12

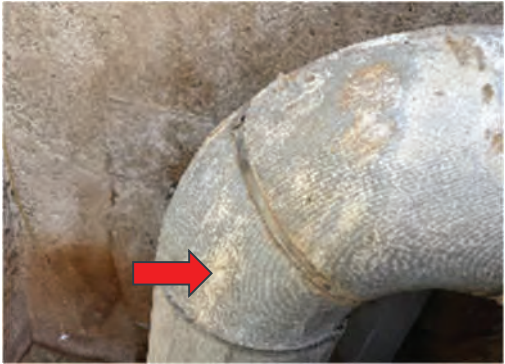
Sample ID	H918-10 A	H923-03 A
Material Description	Asbestos-containing grey caulking in manhole H918	Asbestos-containing beige/grey canvas in manhole H923

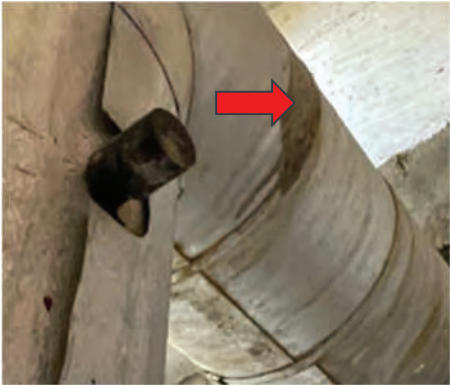
Photo	57

Sample ID	H11-11 A	
Material Description	Asbestos-containing grey caulking on pipe in manhole H11

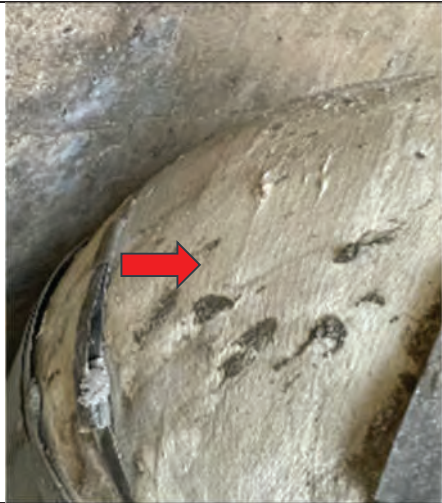
H183-02 A
		Asbestos-containing canvas on pipe in manhole H183
	111	112
Photo

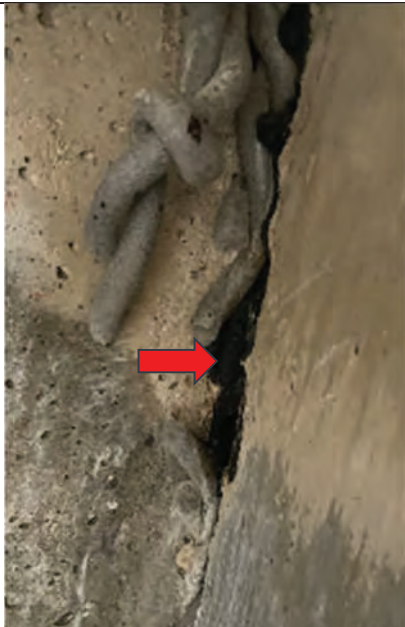
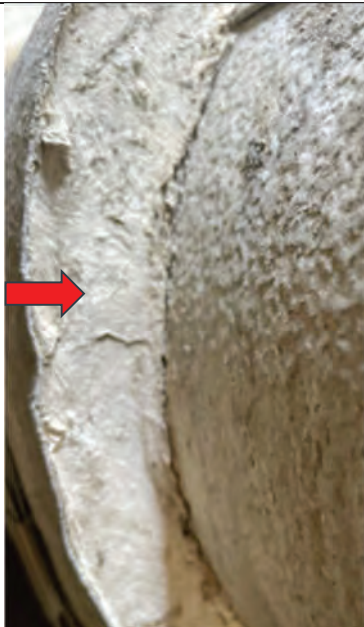
Sample ID	H183-06 A	H183-07 A
Material Description	Asbestos-containing tar in manhole H183	Asbestos-containing parge on pipe in manhole H183

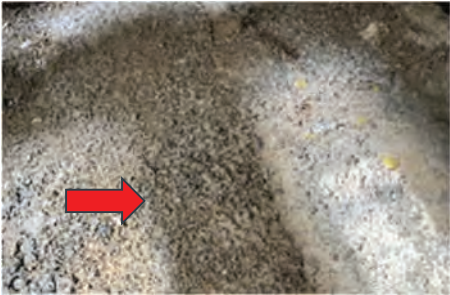
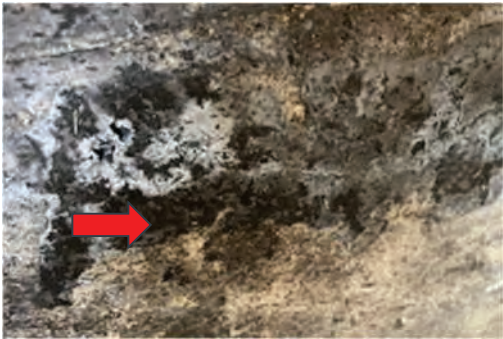
113	114
	<p>Photo</p>

Sample ID	H183-08 A	H183-09 A
Material Description	Asbestos-containing debris in manhole H183	Asbestos-containing tar on concrete in manhole H183

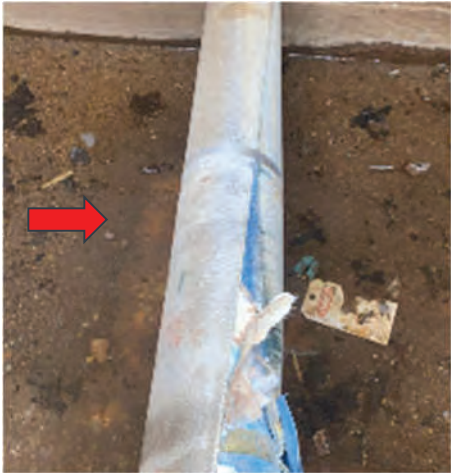
Photo	121

Sample ID	H171-09 A	
Material Description	Asbestos-containing debris in manhole H171	
	122	123

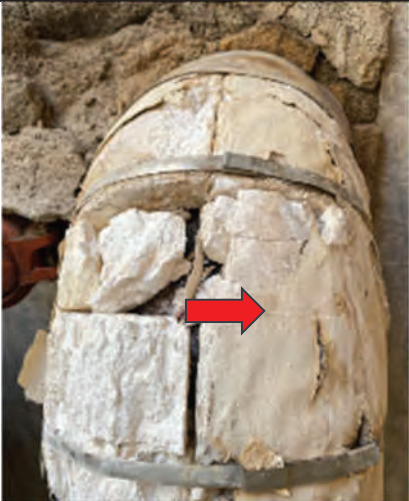
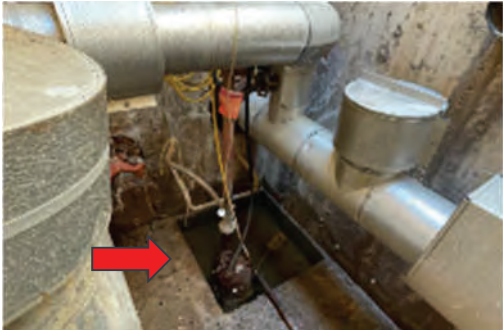
Photo	125	126

Sample ID	H178B-02 A	H178B-05 A
Material Description	Asbestos-containing canvas on pipe in manhole H178B	Asbestos-containing debris in manhole H178B

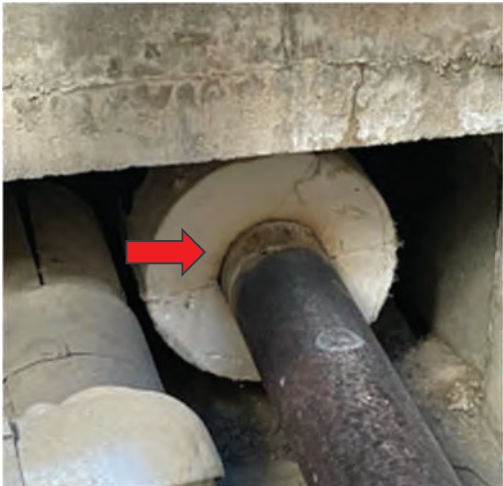
142

H64-02 A
		Asbestos-containing magblock insulation in manhole H64
	143	144
Photo

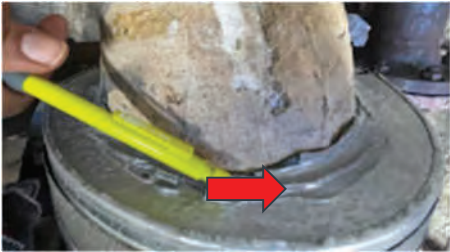
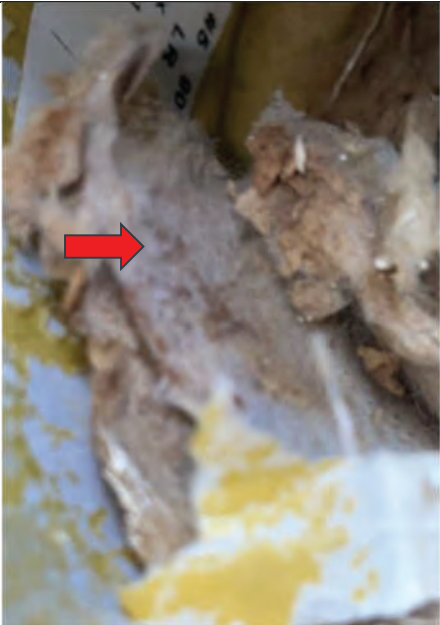
Sample ID	H64-04 A	H64-05 A
Material Description	Asbestos-containing grey caulking in manhole H64	Asbestos-containing red caulking in manhole H64

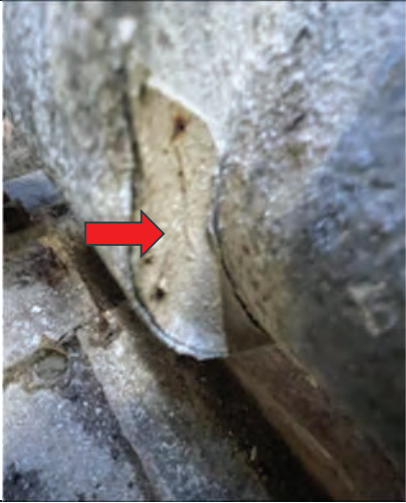
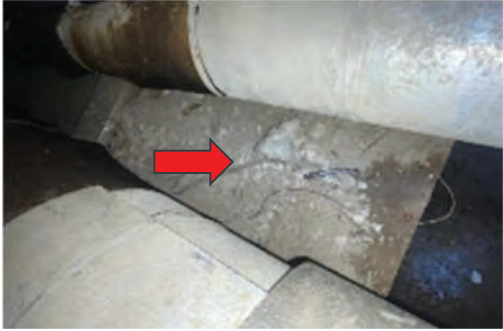
Photo	145	146

Sample ID	H64-06 A	H64-09 A
Material Description	Asbestos-containing pargé on pipe in manhole H64	Asbestos-containing debris in manhole H64
Photo	147	148

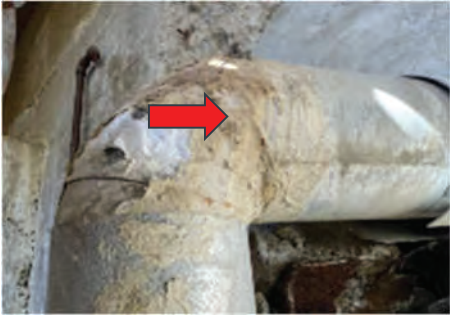
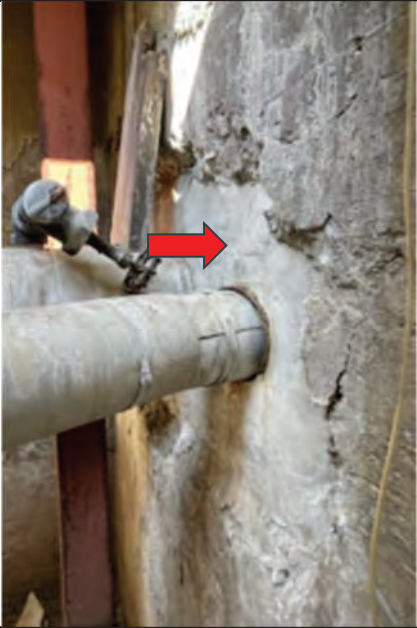
Sample ID	H124-06 A	H124-09 A
Material Description	Asbestos-containing canvas on pipe in manhole H124	Asbestos-containing pargé on wall in manhole H124

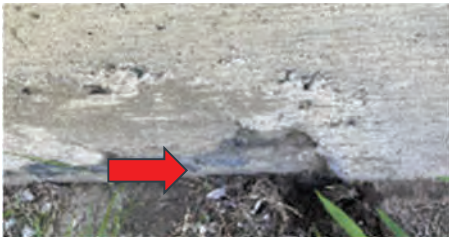
Sample ID	H124-13 A	
Material Description	Asbestos-containing tar membrane on manhole H124

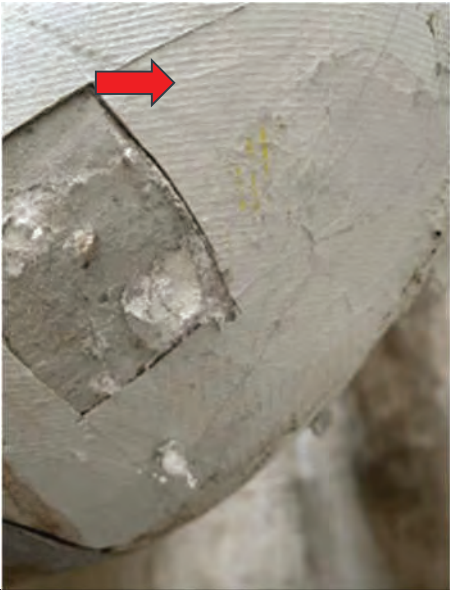
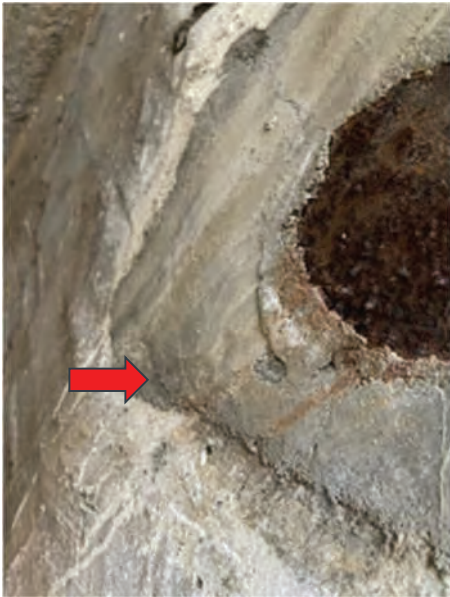
171	172
Photo

Sample ID	H300-02 A	H300-04 A
Material Description	Asbestos-containing canvas on pipe in manhole H300	Asbestos-containing parge on wall in manhole H300

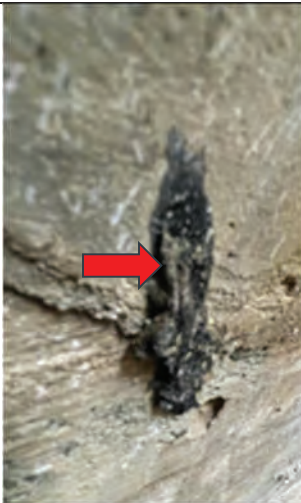
Photo	173	174

Sample ID	H300-08 A	H300-09 A
Material Description	Asbestos-containing tar on concrete in manhole H300	Asbestos-containing debris in manhole H300

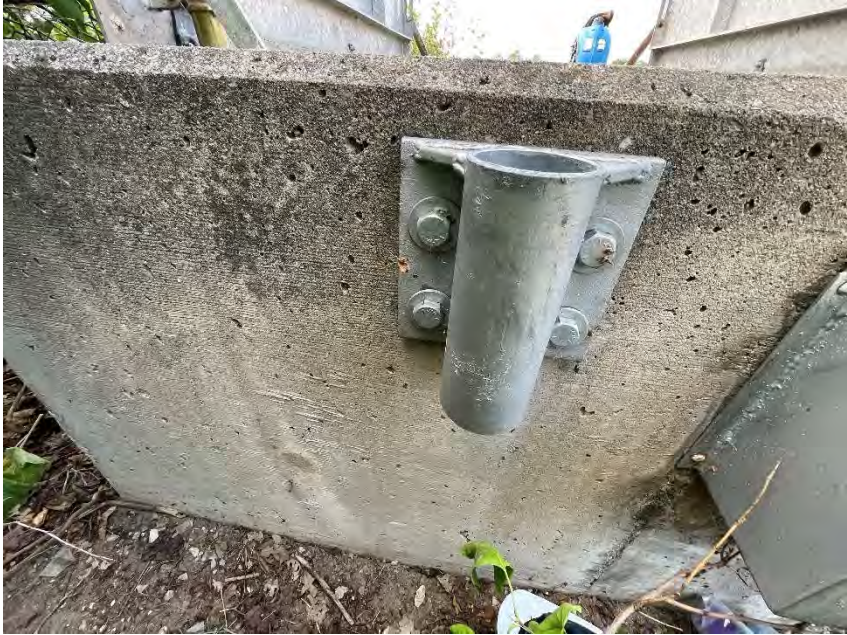
Photo	1

Description	Manhole H11: Harness bracket(s) mounted on exterior surface of manhole (condition photo)
Photo	2

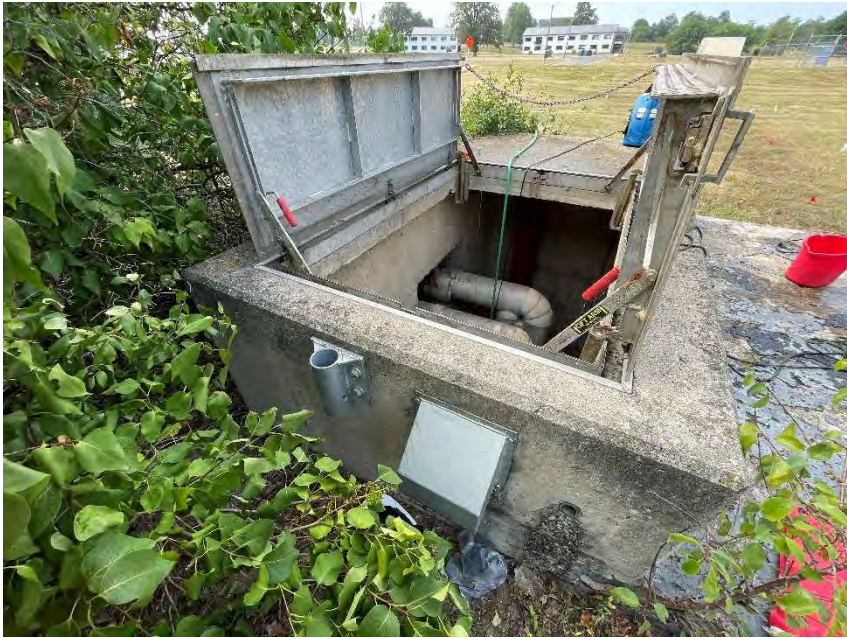
Description	Manhole H11: Harness bracket(s) mounted on exterior surface of manhole (orientation photo)

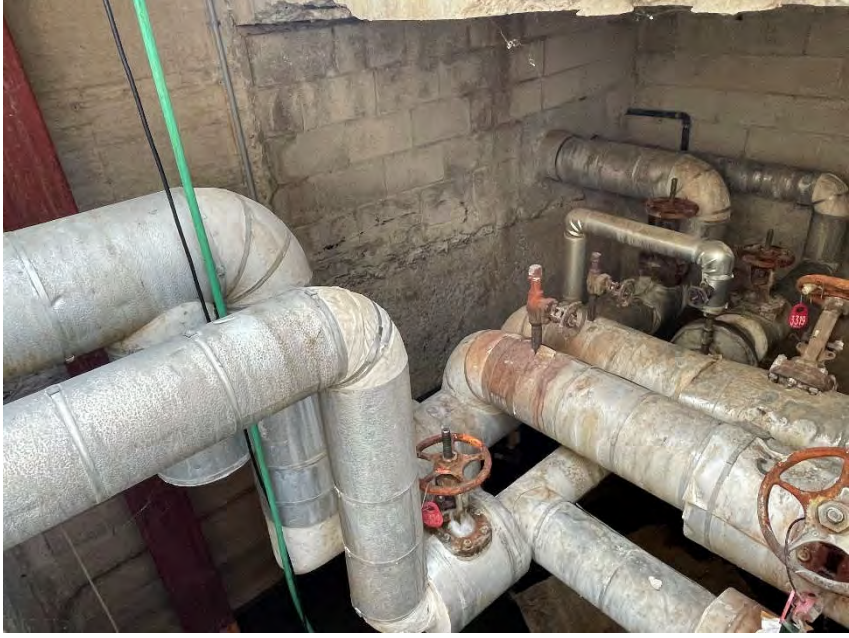
Photo	5

Description	Manhole H11: Full piping layout (Photo 1 of 2)
Photo	6

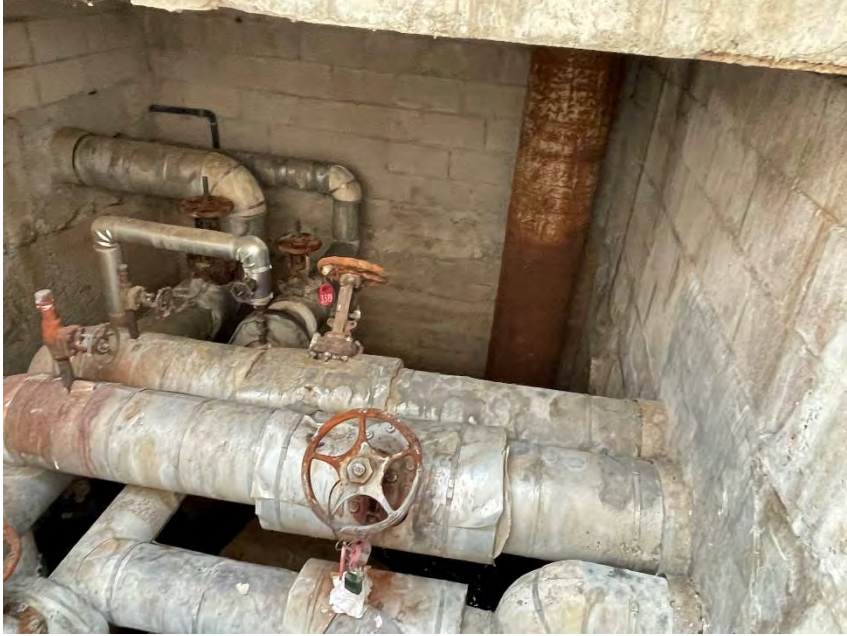
Description	Manhole H11: Full piping layout (Photo 2 of 2)

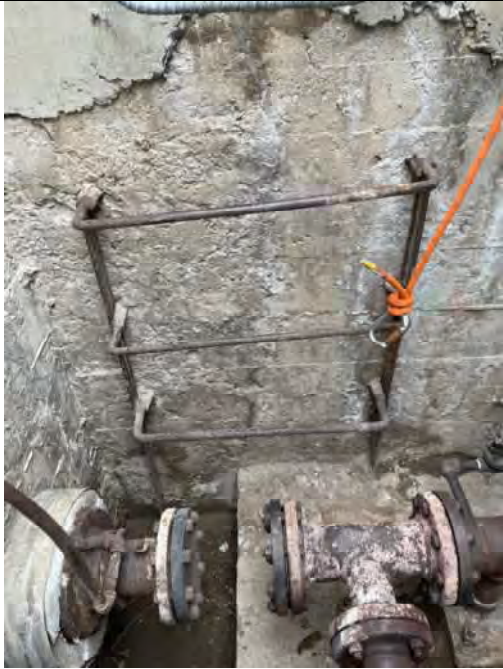
Photo	1

Description	Manhole 64: Ladder / Egress rungs	
Photo	2

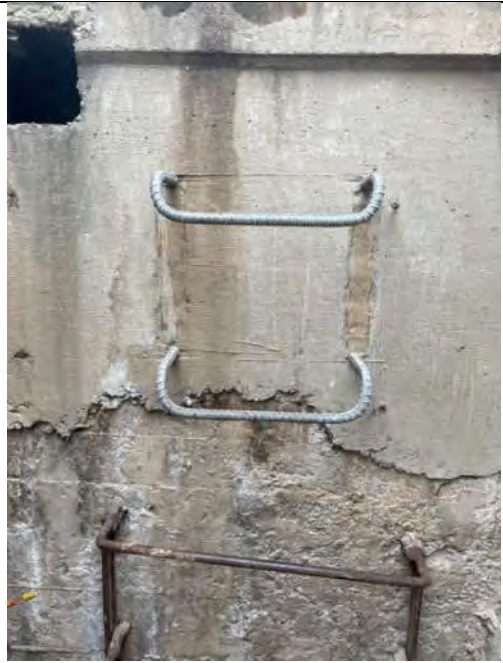
Description	Manhole 64: Ladder / Egress rungs (condition photo)

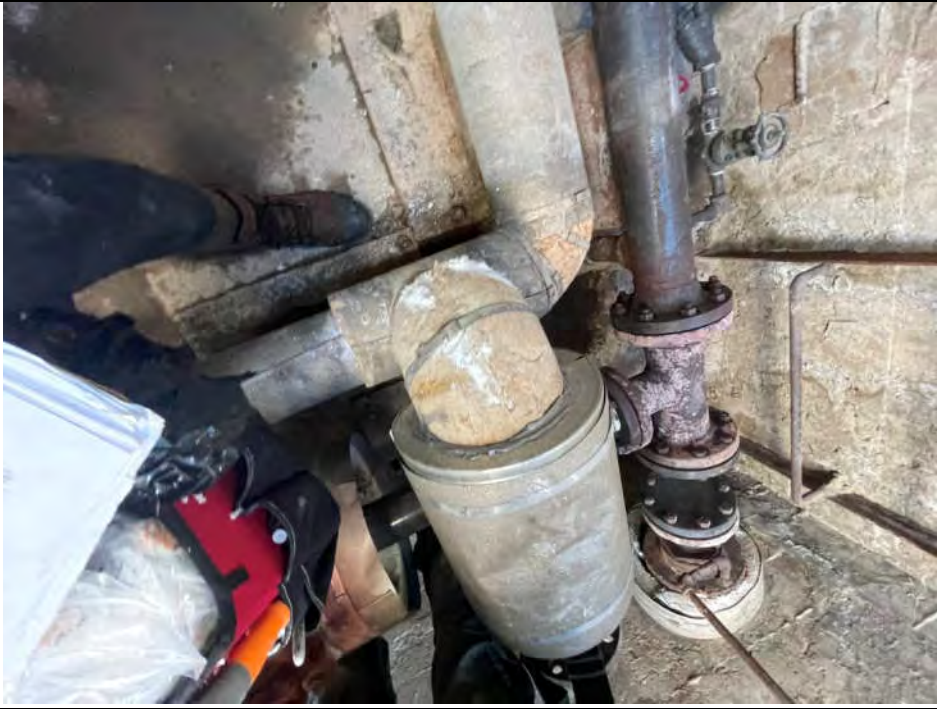
Photo	3

Description	Manhole 64: Full piping layout (Photo 1 of 2)
Photo	4

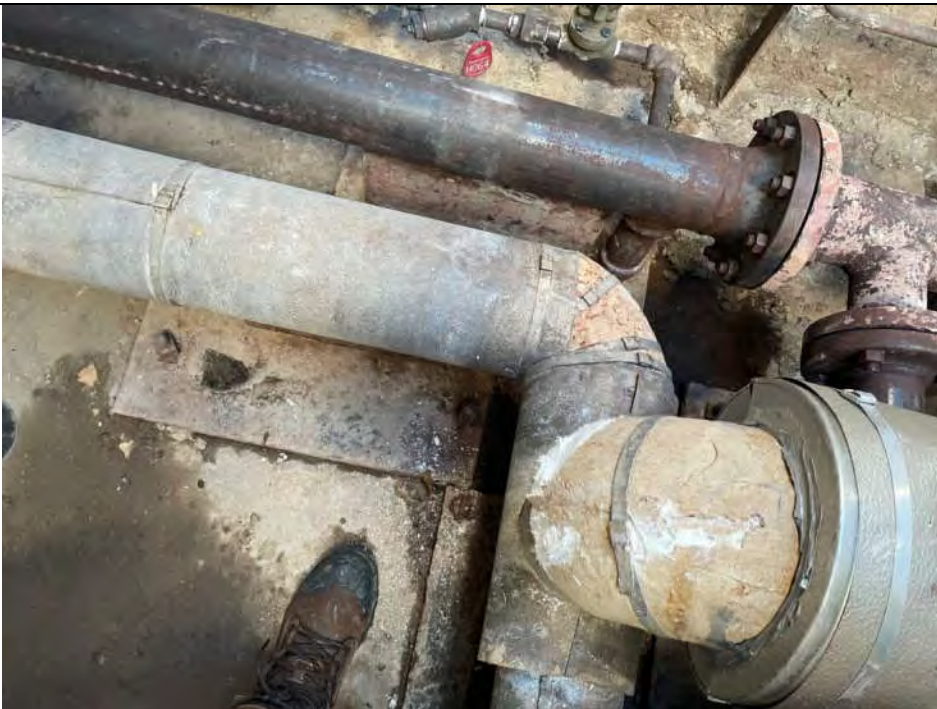
Description	Manhole 64: Full piping layout (Photo 2 of 2)

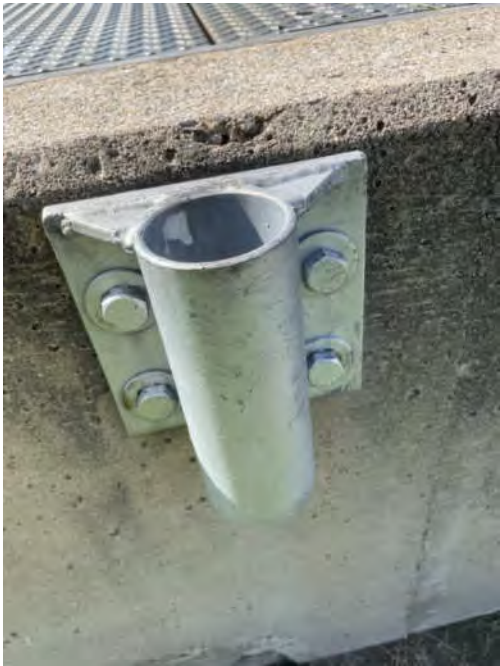
Photo	1

Description	Manhole 124: Harness bracket(s) mounted on exterior surface of manhole (condition photo)
Photo	2

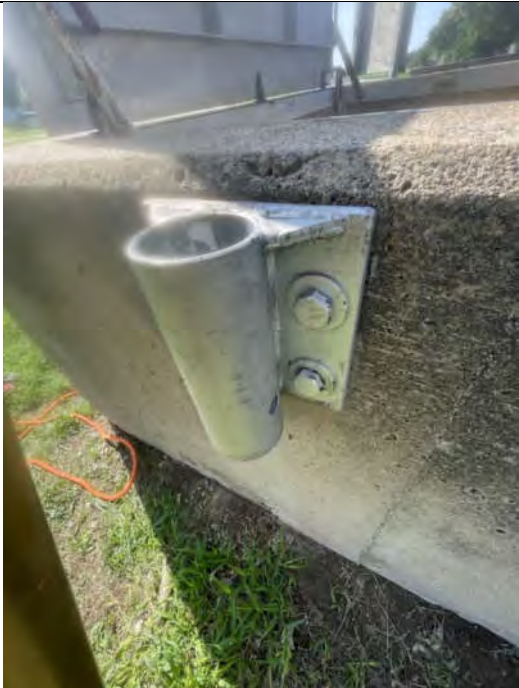
Description	Manhole 124: Harness bracket(s) mounted on exterior surface of manhole (orientation photo)

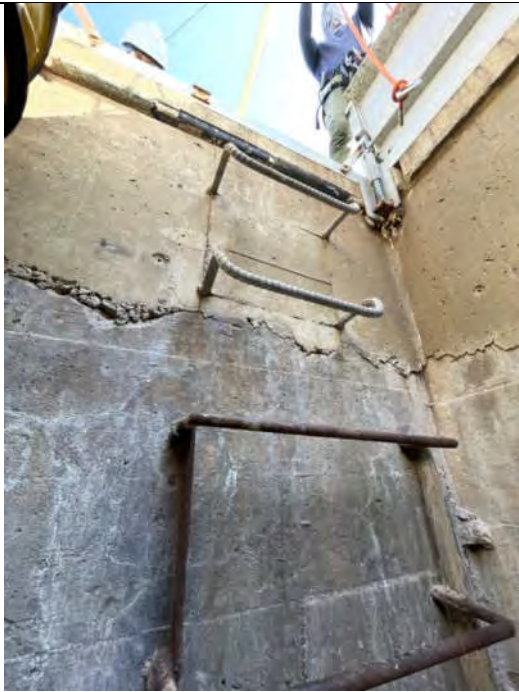
Photo	3

Description	Manhole 124: Ladder / Egress rungs
Photo	4

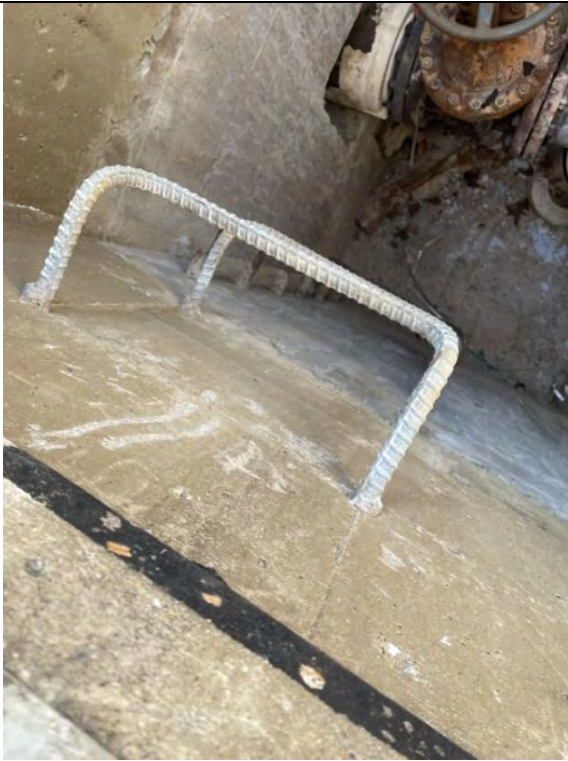
Description	Manhole 124: Ladder / Egress rungs (condition photo)

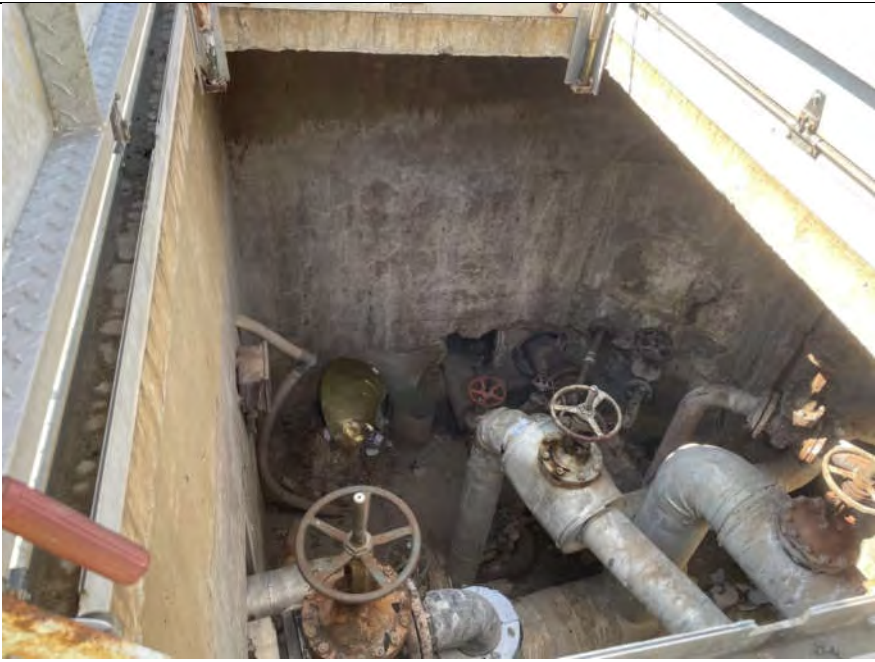
Photo	5

Description	Manhole 124: Full piping layout (Photo 1 of 2)
Photo	6

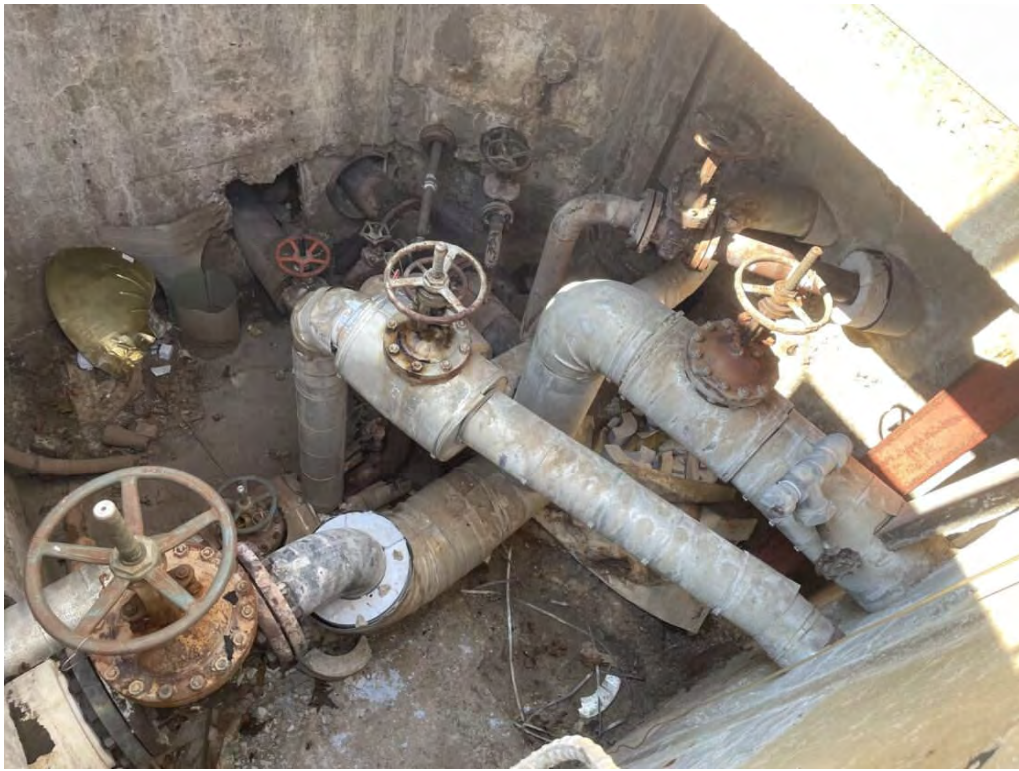
Description	Manhole 124: Full piping layout (Photo 2 of 2)

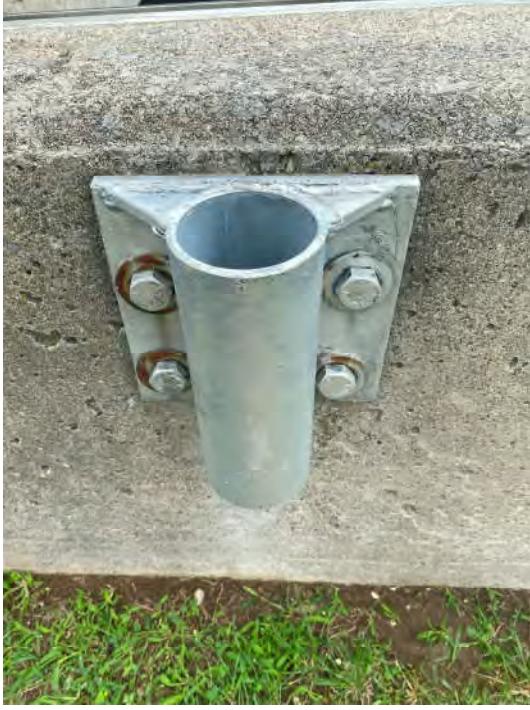
Photo	1

Description	Manhole 171: Harness bracket(s) mounted on exterior surface of manhole (condition photo)
Photo	2

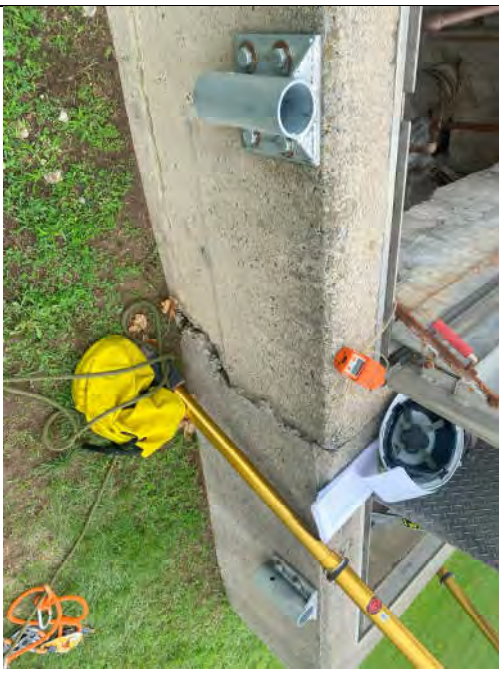
Description	Manhole 171: Harness bracket(s) mounted on exterior surface of manhole (orientation photo)

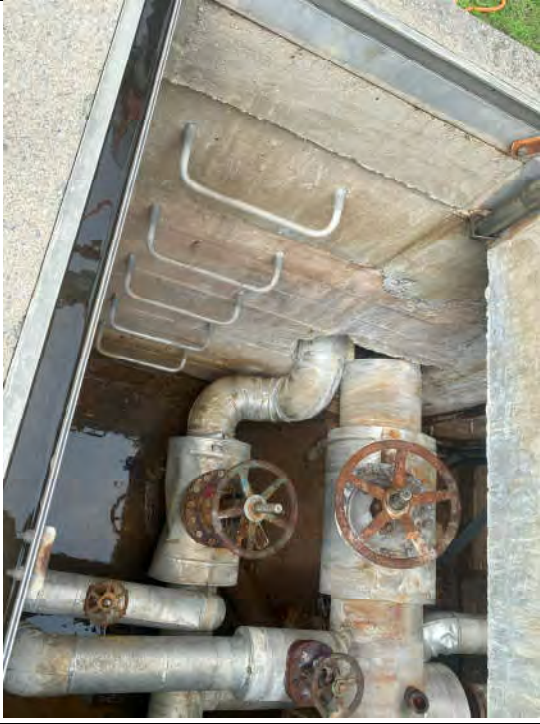
Photo	3

Description	Manhole 171: Ladder / Egress rungs
Photo	4

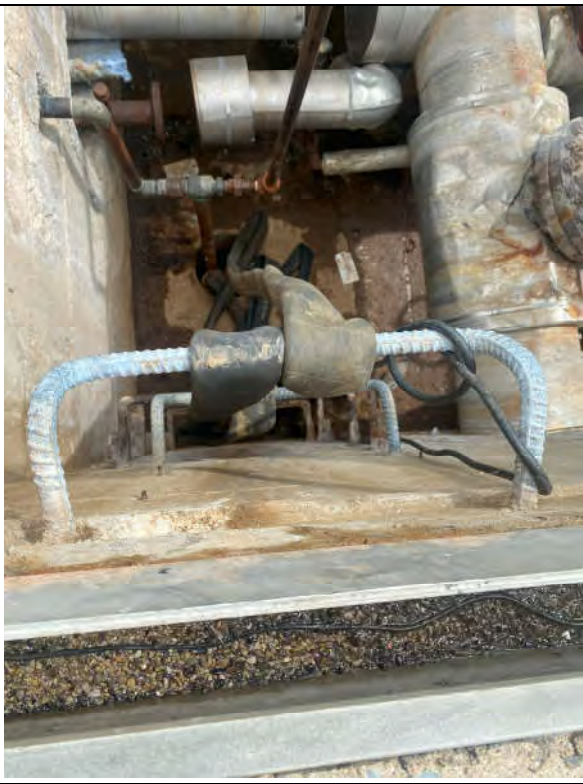
Description	Manhole 171: Ladder / Egress rungs (condition photo)

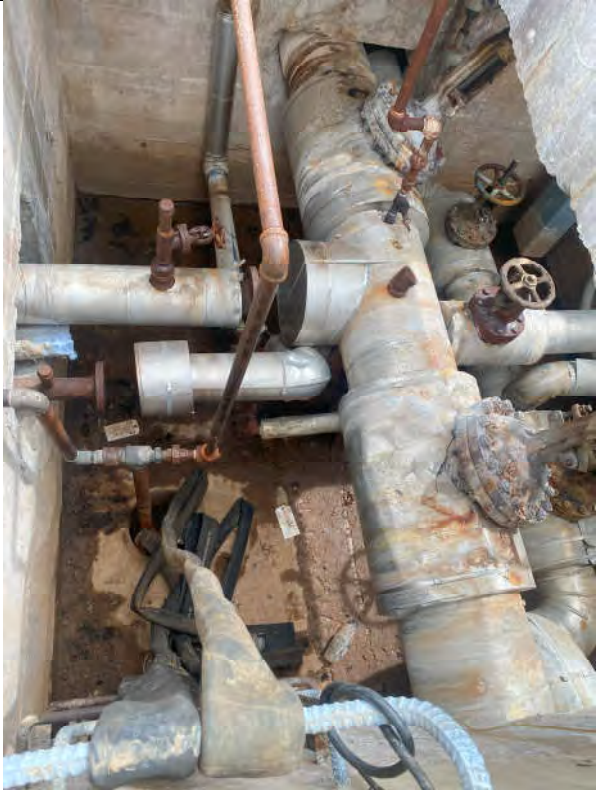
Photo	5

Description	Manhole 171: Full piping layout (Photo 1 of 2)	
Photo	6

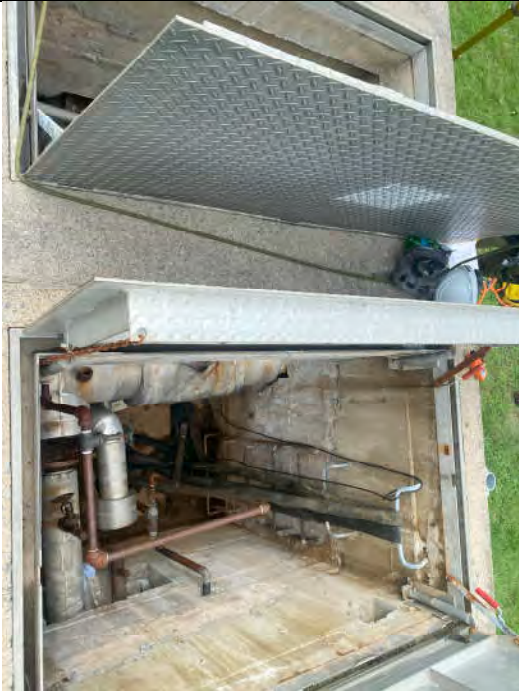
Description	Manhole 171: Full piping layout (Photo 2 of 2)

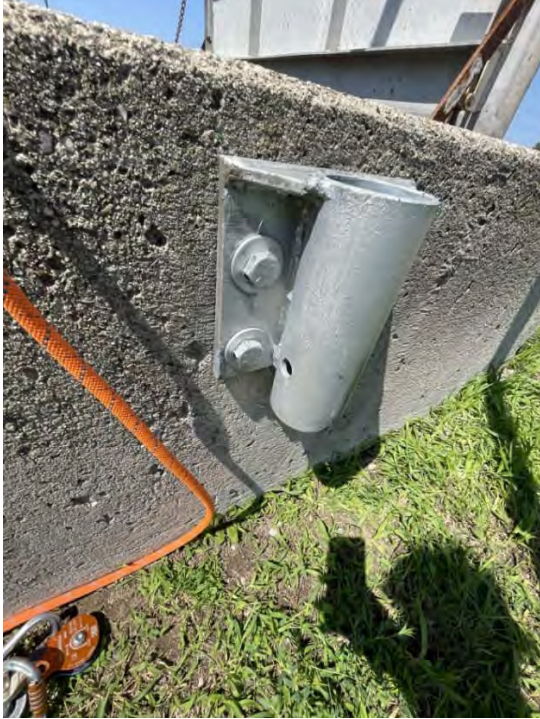
Photo	<div style="text-align: center;">1</div>

<div style="text-align: center;">Description</div> <p>Manhole 178B: Harness bracket(s) mounted on exterior surface of manhole (condition photo)</p>
Photo	<div style="text-align: center;">2</div>

H178B	Asbestos	Canvas	White	Good	on pipe insulation	Chrysotile 5%	Friable	3 LM	condition, plate checked	
H178B	Asbestos	Transite Pipe	Grey	Good	on ground	Amosite: 3% Chrysotile 5%	Non-Friable	1 LM		
H183	Asbestos	Debris	Brown	Debris	on floor	Chrysotile 1%	Friable	16 sq. m.	Safe to use: Good condition, plate checked	
H183	Asbestos	Canvas	White	Good	on fittings	Chrysotile 2%	Friable	1 sq. m.		Location not in photo.
H183	Asbestos	Tar	Black	Good	around pipe chase structure	Chrysotile 4%	Non-Friable	2 sq. m.		
H183	Asbestos	Parging associated with piping	White	Good	on pipe ends	Chrysotile 3%	Friable	1 sq. m.		Location not in photo.
H183	Asbestos	Tar	Black	Good	on wall, patches	Chrysotile 1%	Non-Friable	2 sq. m.		
H183	Asbestos	Gasket	Not Applicable	Good	on piping	Suspect	Non-Friable	1		Assumed asbestos until analytical results confirm otherwise. Not able to sample due to inaccessible location.
H300	Asbestos	Canvas	White	Good	on pipe insulation	Chrysotile 2%	Friable	4 LM	Safe to use: Surface cracks, good condition, plate checked

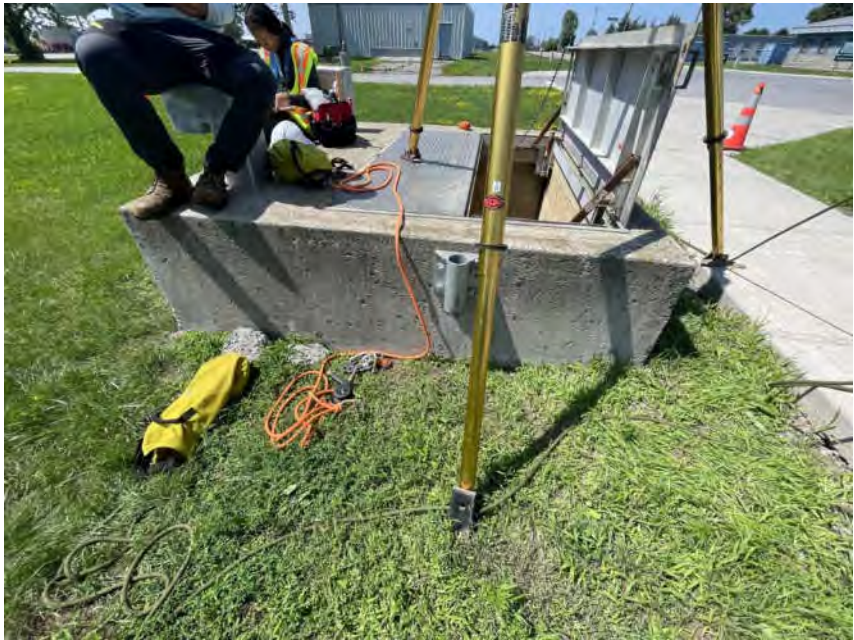
<div style="text-align: center;">Description</div> <p>Manhole 178B: Harness bracket(s) mounted on exterior surface of manhole (orientation photo)</p>

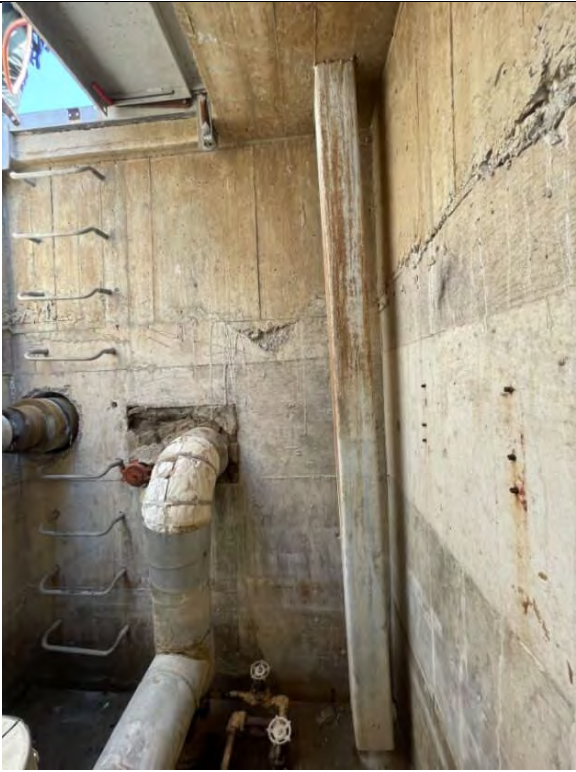
Photo	3

Description	Manhole 178B: Ladder / Egress rungs
Photo	4

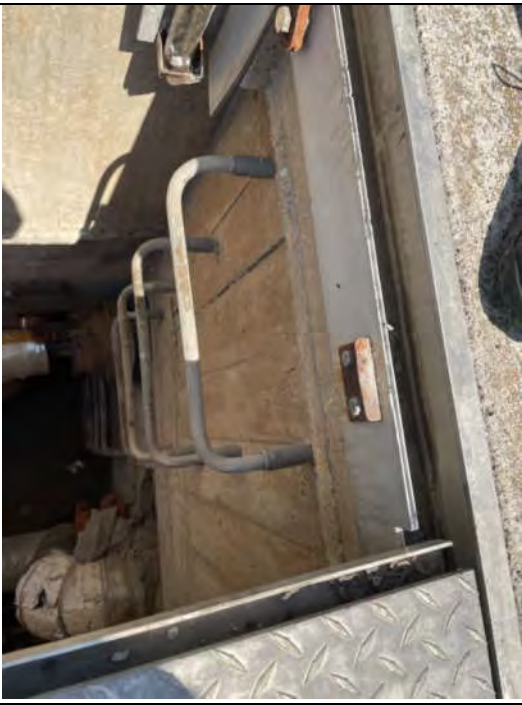
Description	Manhole 178B: Ladder / Egress rungs (condition photo)

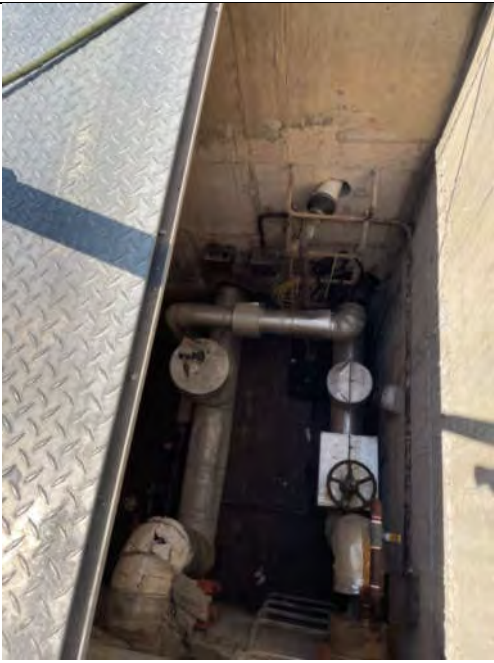
Photo	5

Description	Manhole 178B: Full piping layout (Photo 1 of 2)
Photo	6

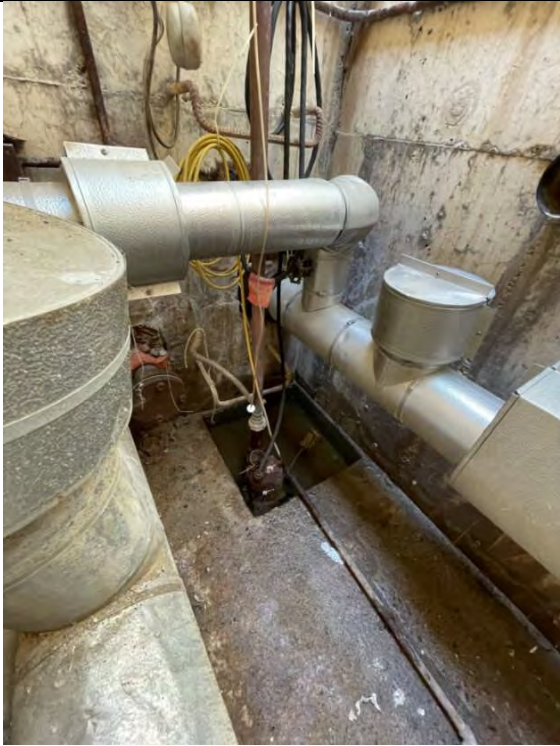
Description	Manhole 178B: Full piping layout (Photo 2 of 2)

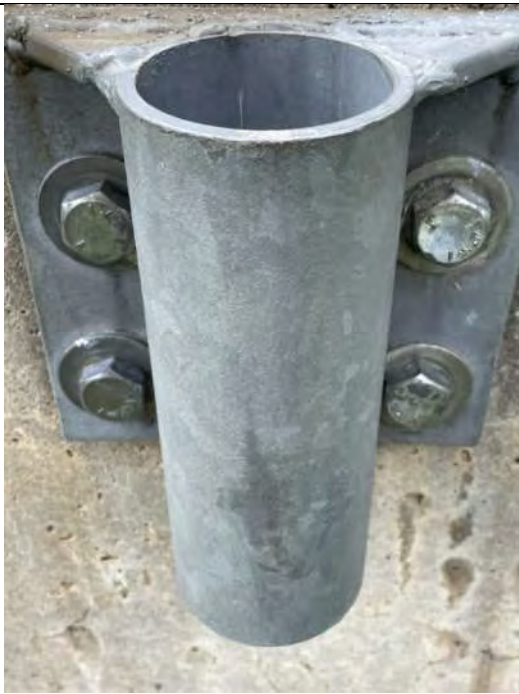
Photo	1

Description	Manhole 300: Harness bracket(s) mounted on exterior surface of manhole (condition photo)
Photo	2

H300	Asbestos	Cementitious Parge	Grey	Good	on walls, third tar layer	Chrysotile 7%	Non-Friable	12 sq. m.		
H300	Asbestos	Tar	Black	Good	on east pipe chase	Chrysotile 2-10%	Non-Friable	2 sq. m.		
H300	Asbestos	Tar Membrane	Black	Good	on wall	Suspect	Non-Friable	4 sq. m.		Assumed asbestos until analytical results confirm otherwise. Not able to sample due to inaccessible location.
H300	Asbestos	Debris	Brown	Debris	on floor	Chrysotile 3%	Friable	4 sq. m.		
H478	Asbestos	Gasket	Black	Good	on fittings	Suspect	Non-Friable	4 gaskets	Safe to use: Good condition, plate checked	Assumed asbestos until analytical results confirm otherwise. Not able to sample due to inaccessible location.
H478	Asbestos	Debris	Brown	Debris	on floor	Amosite 3%	Friable	6 sq. m.		
H855	Asbestos	Tar Material	Black	Good	around pipe run	Chrysotile 25%	Friable	<1 sq. m.	Not safe for use: Concrete walls in very poor condition, decay and delamination

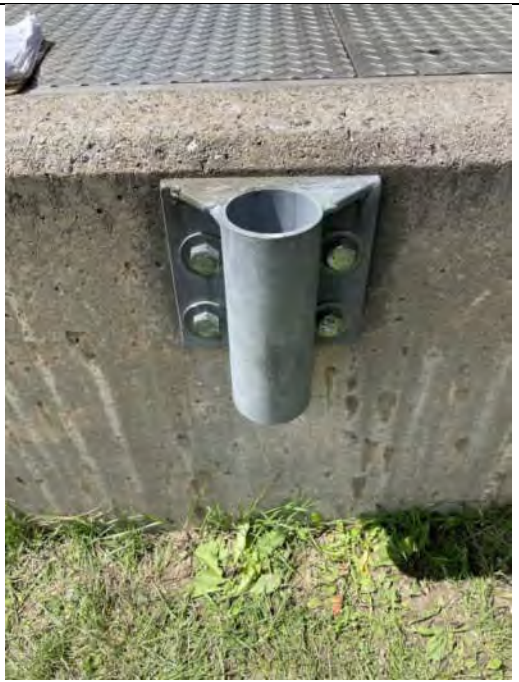
Description	Manhole 300: Harness bracket(s) mounted on exterior surface of manhole (orientation photo)

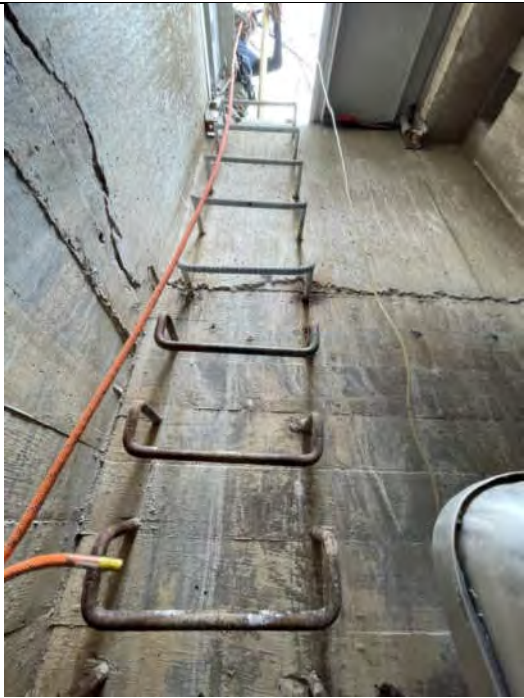
Photo	3

Description	Manhole 300: Ladder / Egress rungs	
Photo	4

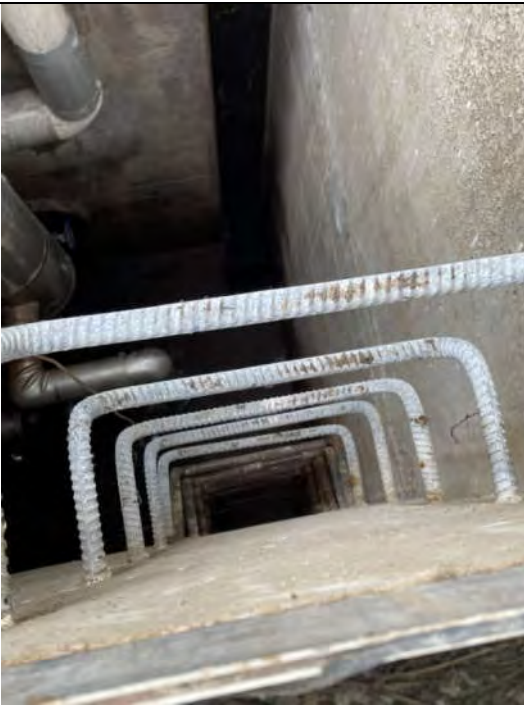
Description	Manhole 300: Ladder / Egress rungs (condition photo)

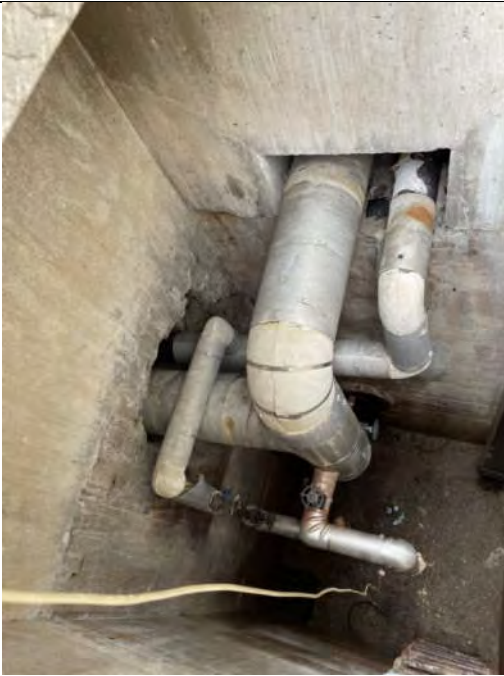
Photo	5

Description	Manhole 300: Full piping layout (Photo 1 of 2)
Photo	6

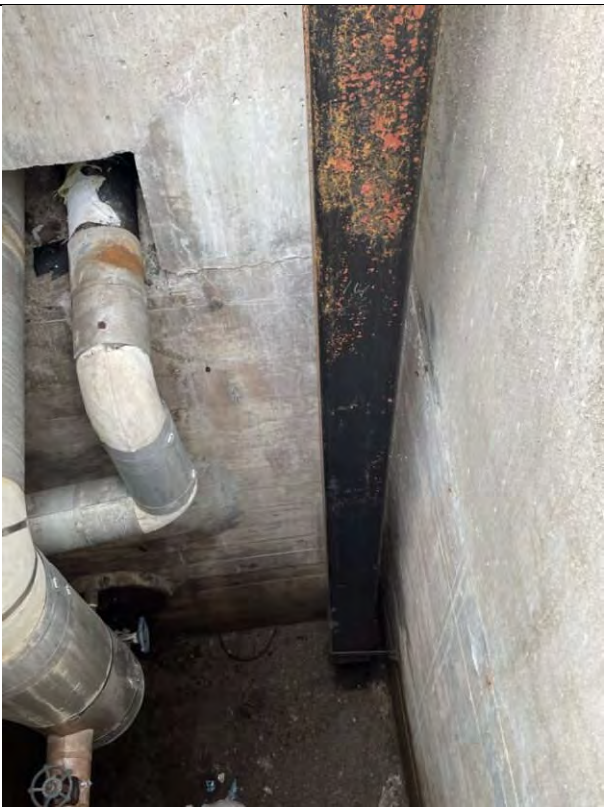
Description	Manhole 300: Full piping layout (Photo 2 of 2)

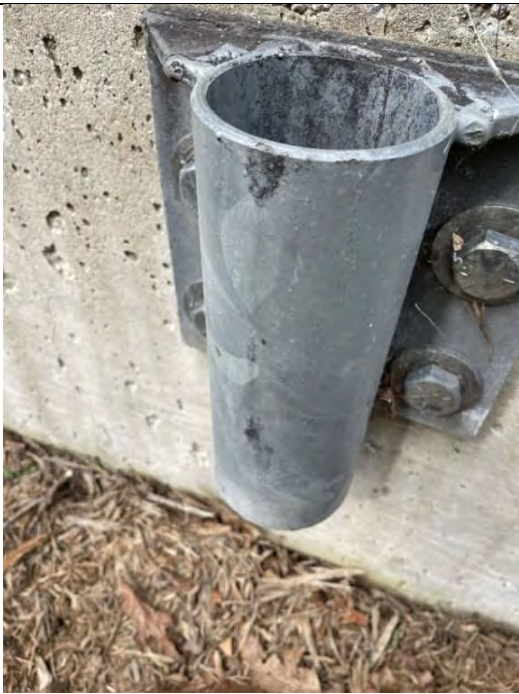
Photo	1

Description	Manhole 478: Harness bracket(s) mounted on exterior surface of manhole (condition photo)
Photo	2

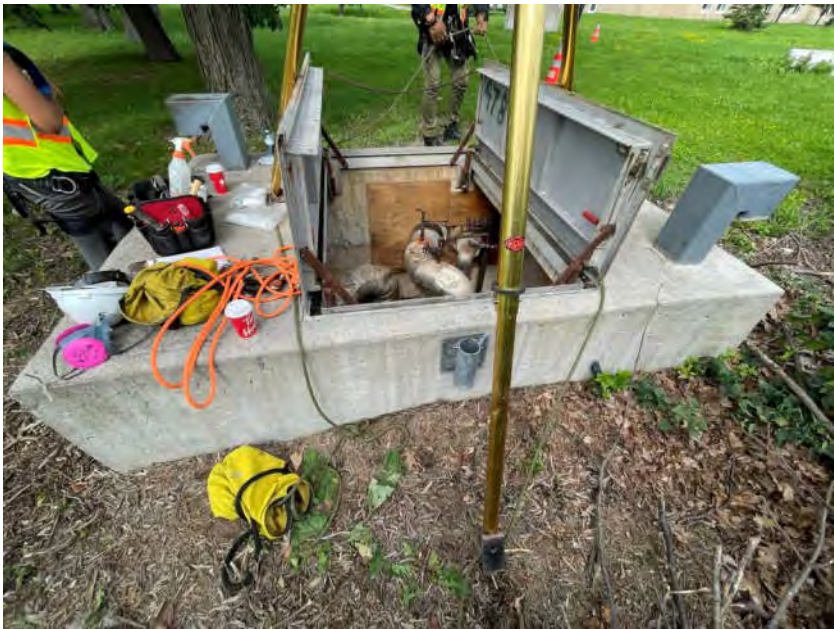
Description	Manhole 478: Harness bracket(s) mounted on exterior surface of manhole (orientation photo)
Photo	3

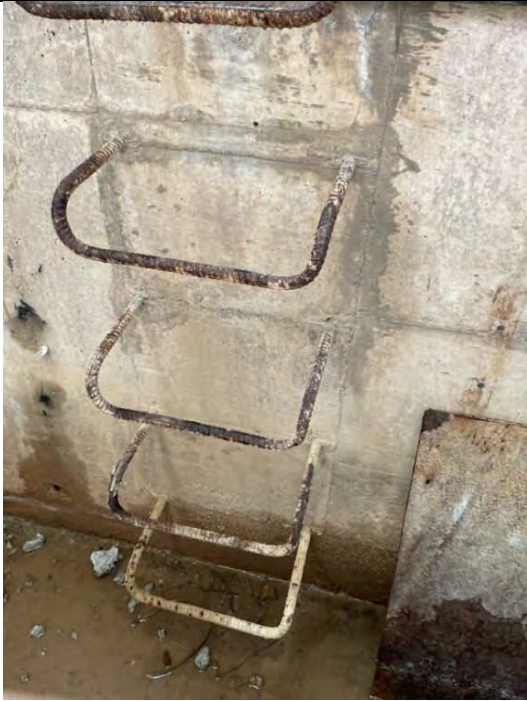
Description	Manhole 478: Ladder / Egress rungs	
Photo	4

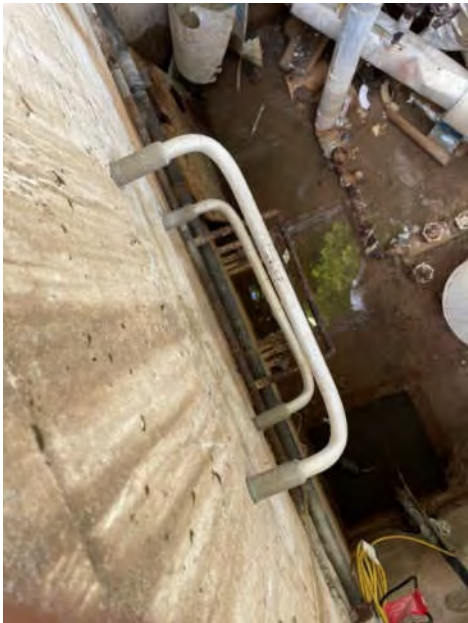
Description	Manhole 478: Ladder / Egress rungs (condition photo)

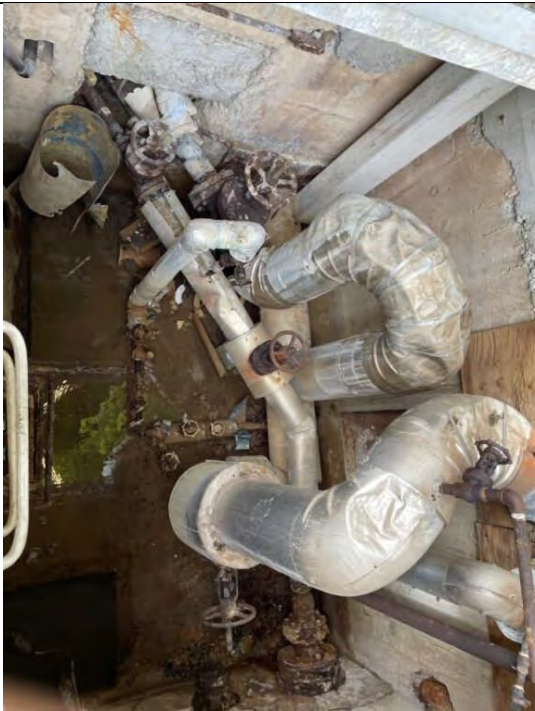
Photo	5

Description	Manhole 478: Full piping layout (Photo 1 of 2)	
Photo	6

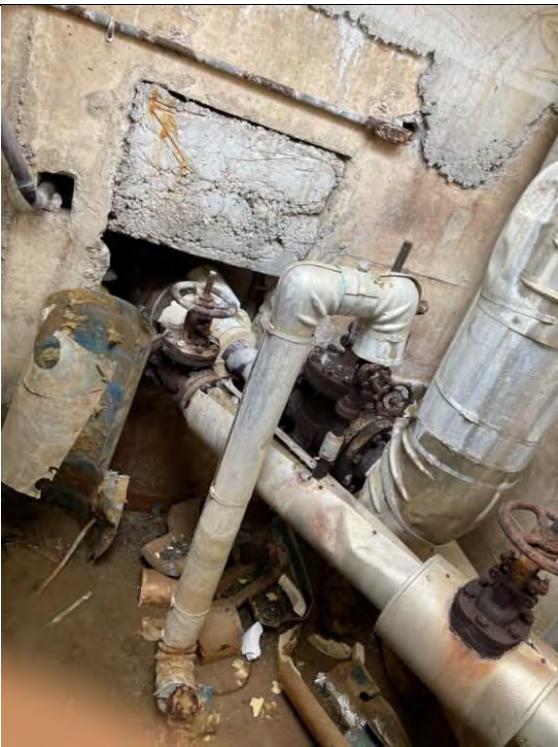
Description	Manhole 478: Full piping layout (Photo 2 of 2)
