- 1.1. This statement of work (SOW) describes the services and deliverables required for the provisions of hazardous materials abatement for the Department of National Defence.

- 2.1. Supply all materials, labour, transportation and supervision at thirteen (13) steam vaults requiring Asbestos Containing Materials (ACM's) abatement. Scope of Asbestos Containing Materials (ACM) to be abated are in Appendix A. Notes on davit arm bracket condition status are also included in Appendix A for each steam vault. The professional engineer "Davit arm mounting plates Inspection" letter report by KNACO Design & Construction Ltd, dated December 27, 2022, can be provided to the Contractor after award, upon request.

- 2.2. Steam vaults requiring asbestos abatement:
1. H11
 2. H64
 3. H124
 4. H171
 5. H178
 6. H178B
 7. H183
 8. H300
 9. H478
 10. H855
 11. H903A
 12. H918
 13. H923

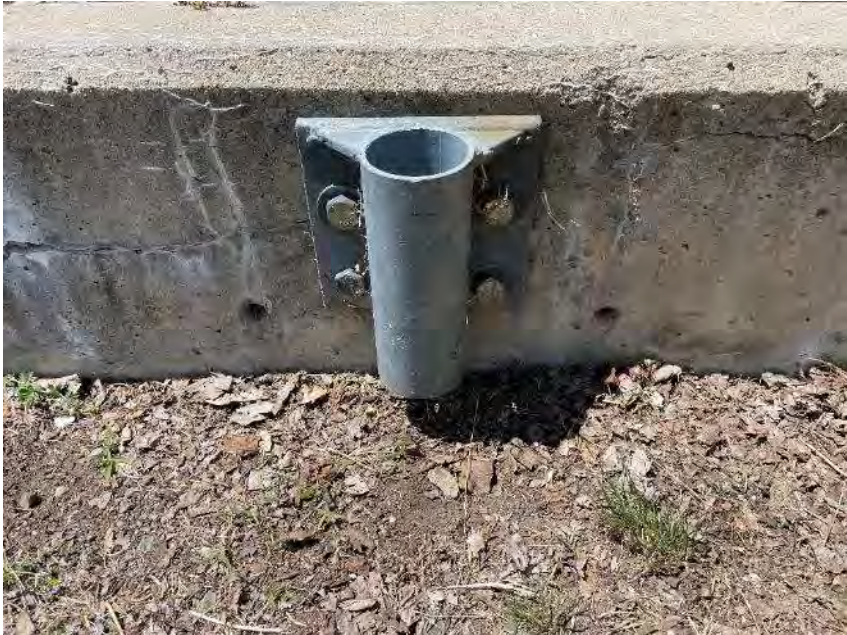
Photo	1

Description	Manhole 855: Harness bracket(s) mounted on exterior surface of manhole (condition photo)
Photo	2

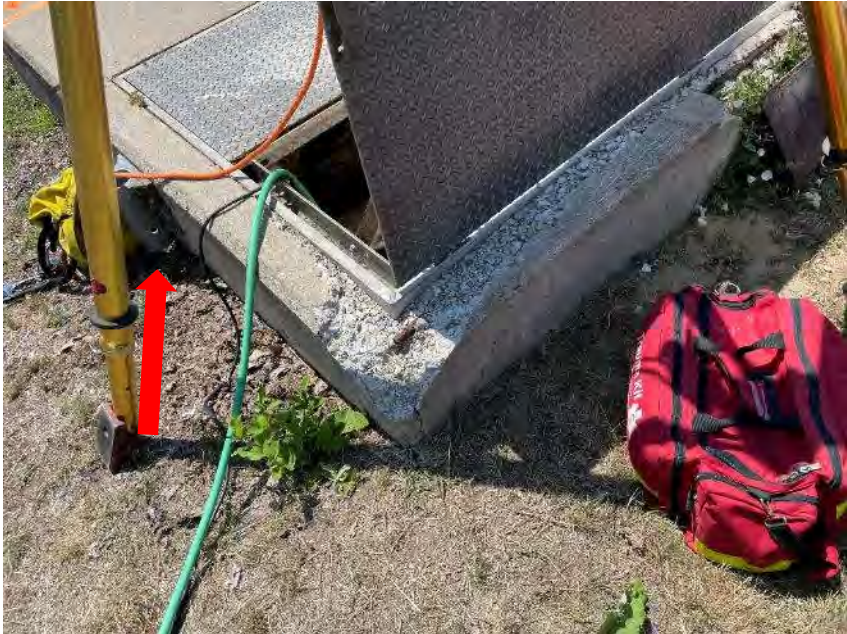
Description	Manhole 855: Harness bracket(s) mounted on exterior surface of manhole (orientation photo)

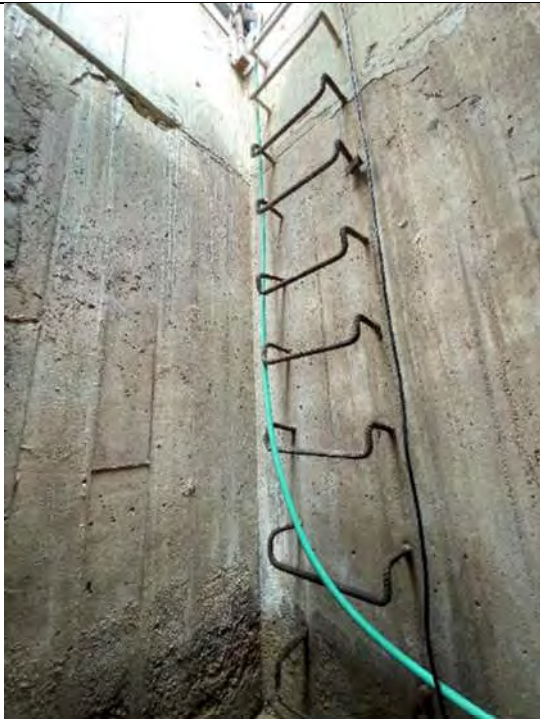
Photo	3

Description	Manhole 855: Ladder / Egress rungs	
Photo	4

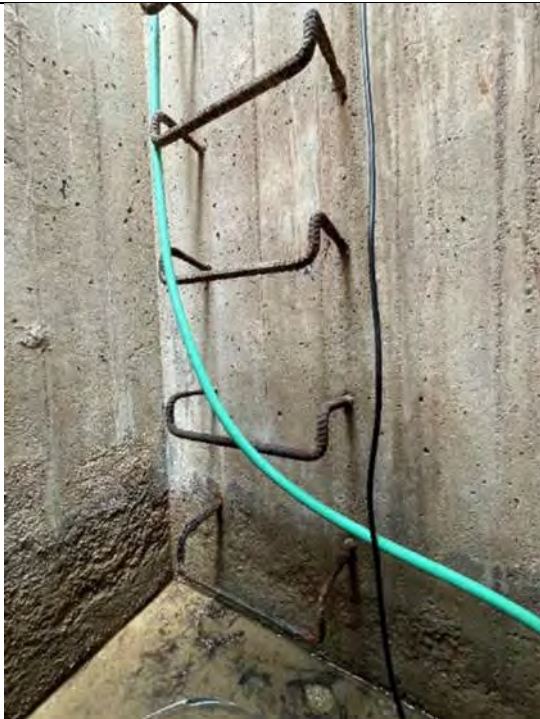
Description	Manhole 855: Ladder / Egress rungs (condition photo)

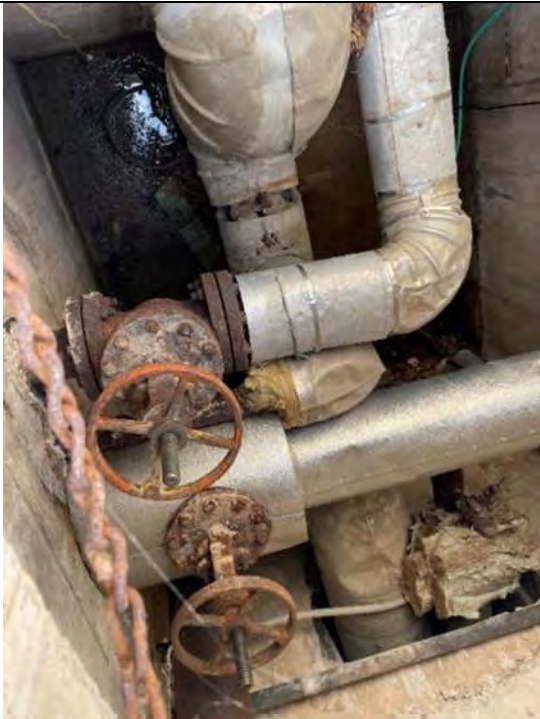
Photo	5

A photograph showing a complex arrangement of industrial piping within a manhole. The pipes are primarily white with some sections wrapped in yellow insulation. Two large, rusty metal valves with handwheels are visible. A thick, orange chain hangs on the left side of the frame. The background is dark and appears to be the interior of a concrete structure.
Description	Manhole 855: Full piping layout (Photo 1 of 2)
Photo	6

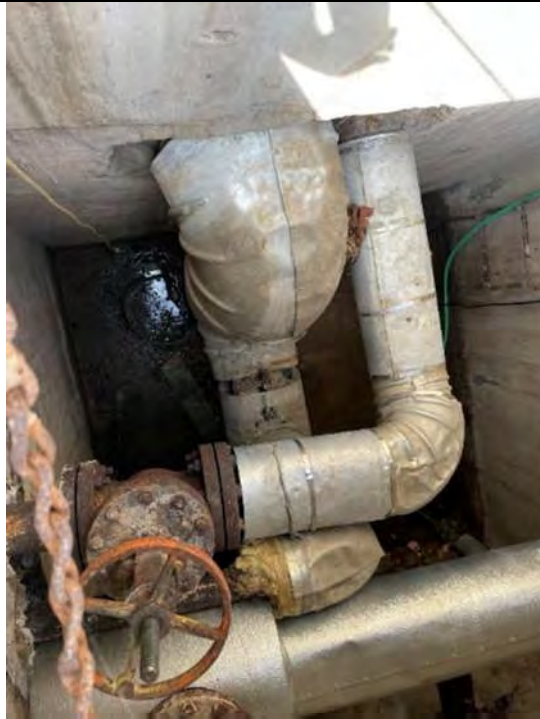
A second photograph of the same piping system in Manhole 855, showing a different angle or a closer view of the same components. It highlights the white pipes, the yellow insulation, and the rusty valves. The orange chain is also visible on the left.
Description	Manhole 855: Full piping layout (Photo 2 of 2)

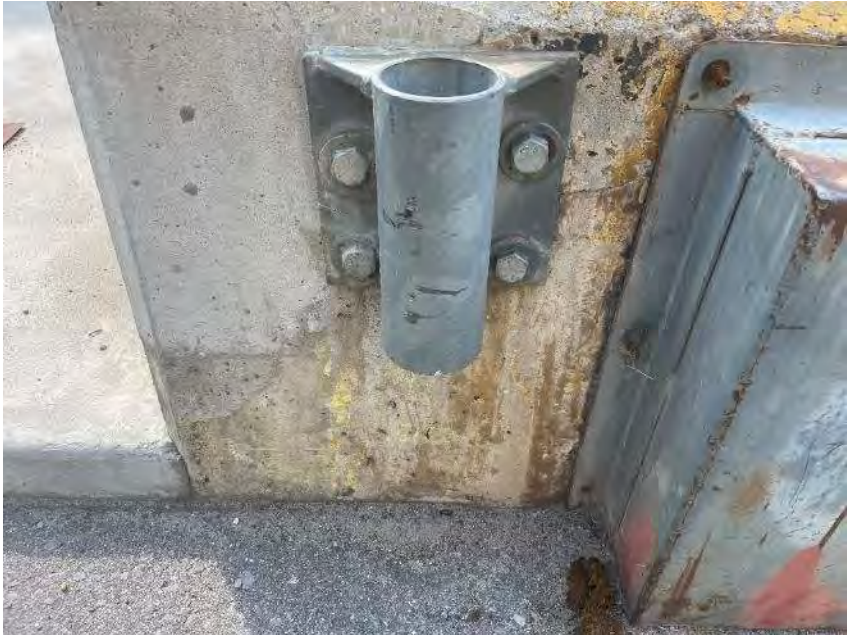
Photo	1

Description	Manhole 903A: Harness bracket(s) mounted on exterior surface of manhole (condition photo)
Photo	2

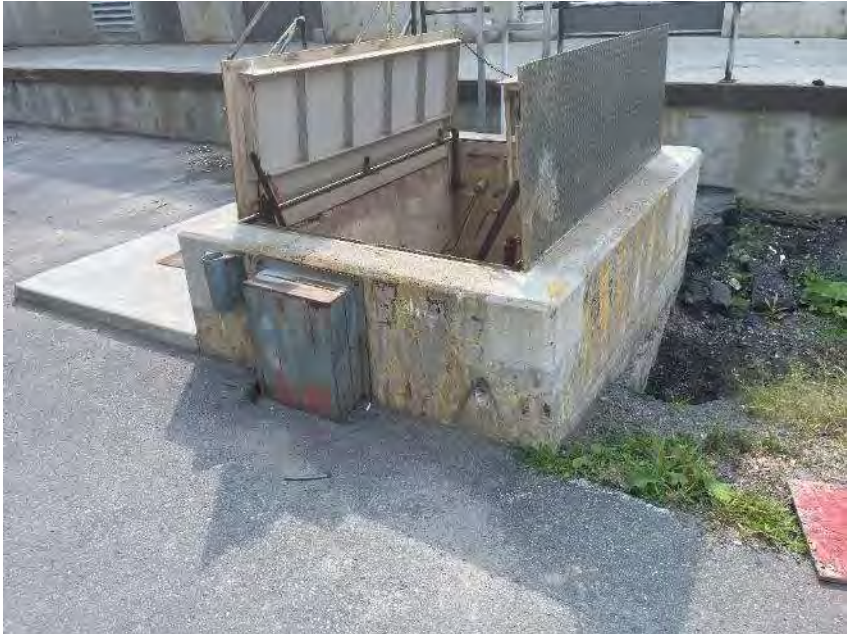
Description	Manhole 903A: Harness bracket(s) mounted on exterior surface of manhole (orientation photo)

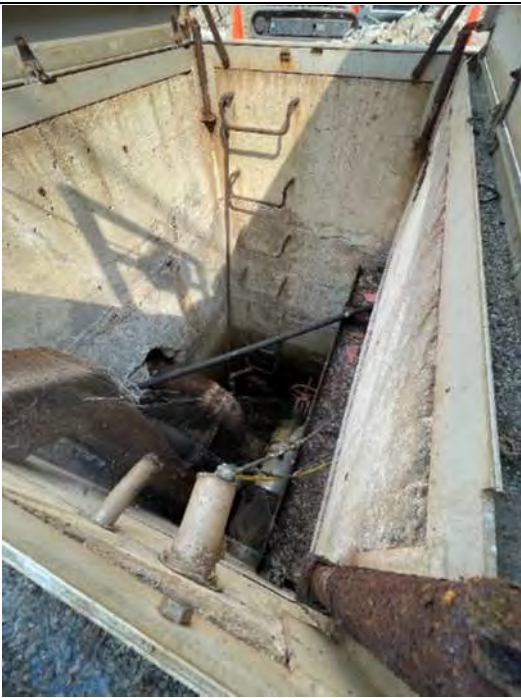
Photo	3

Description	Manhole 903A: Ladder / Egress rungs
Photo	4

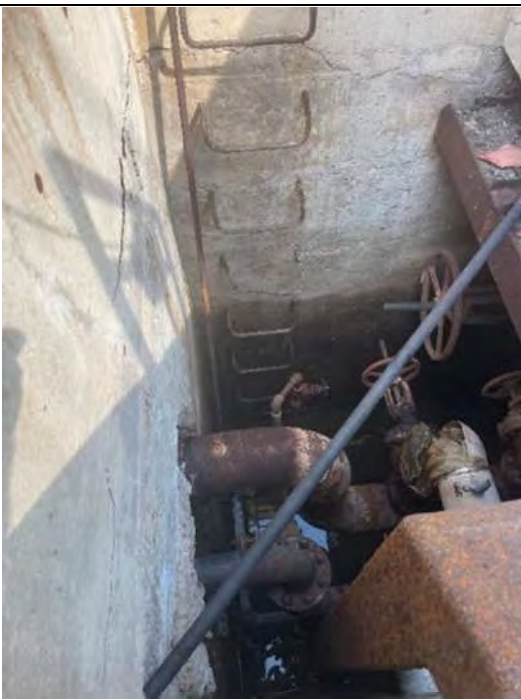
Description	Manhole 903A: Ladder / Egress rungs (condition photo)

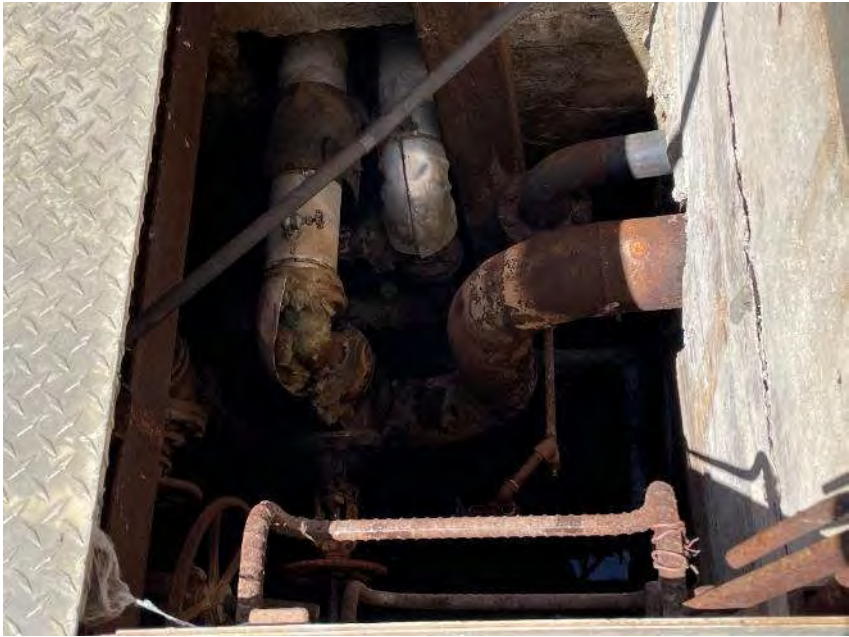
Photo	5

Description	Manhole 903A: Full piping layout (Photo 1 of 2)
Photo	6

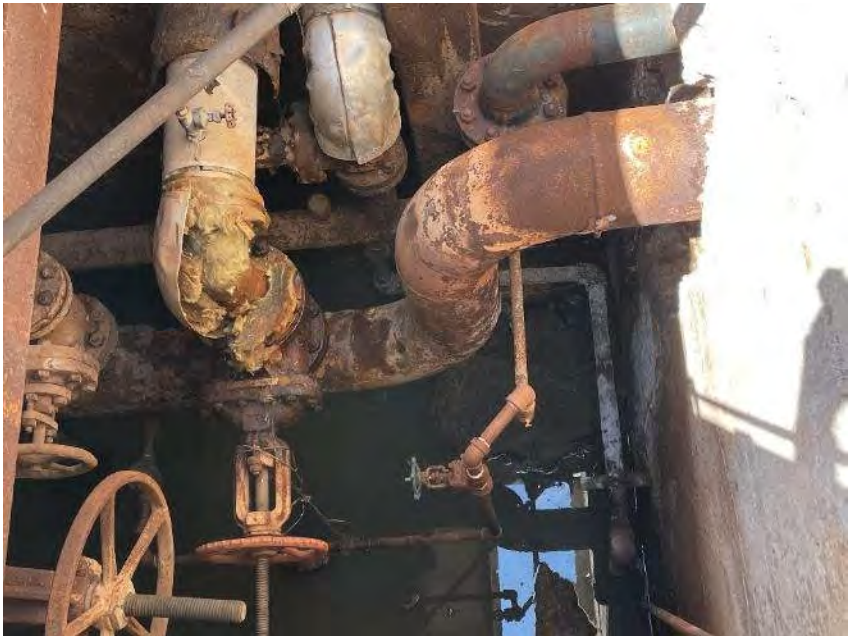
Description	Manhole 903A: Full piping layout (Photo 2 of 2)

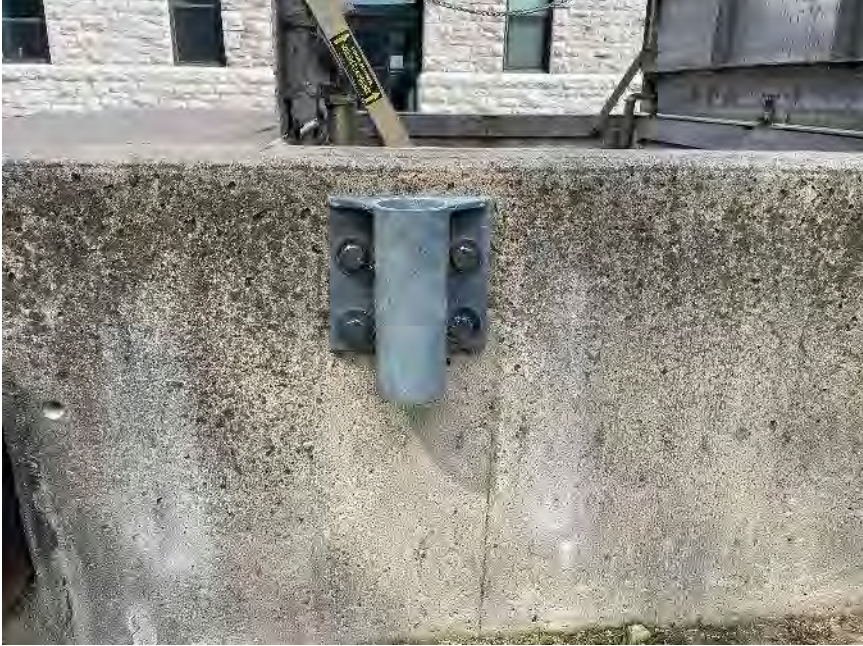
Photo	1

Description	Manhole 982: Harness bracket(s) mounted on exterior surface of manhole (condition photo)
Photo	2

H918	Asbestos	Canvas	Beige	Poor	associated with fiberglass pipe run insulation	Chrysotile 3%	Friable	1 sq. m.	Safe to use: General good condition, plate checked	
H918	Asbestos	Debris	Brown/Grey	Debris	debris (mixed materials)	Chrysotile 1%	Friable	8 sq. m.		
H918	Asbestos	Yellow Insulation	Yellow	Poor	on pipe penetration	Chrysotile 5%	Friable	1.5 sq. m.		
H918	Asbestos	Grey Rigid Caulking	Grey	Good	on pipe run	Chrysotile 4%	Non-Friable	<1 sq. m.		
H923	Asbestos	Beige Canvas	Beige	Poor	associated with pipe run	Chrysotile 5%	Friable	<1 sq. m.	Safe to use: Hair cracks at the corners, plate checked	
H923	Asbestos	Parging associated with piping	Grey	Poor	on top of mag block insulation	Chrysotile 8% & 10%	Friable	2 fittings		
H923	Asbestos	Debris	Brown	Poor	debris (mixed materials)	Chrysotile 2%	Friable	10 sq. m.

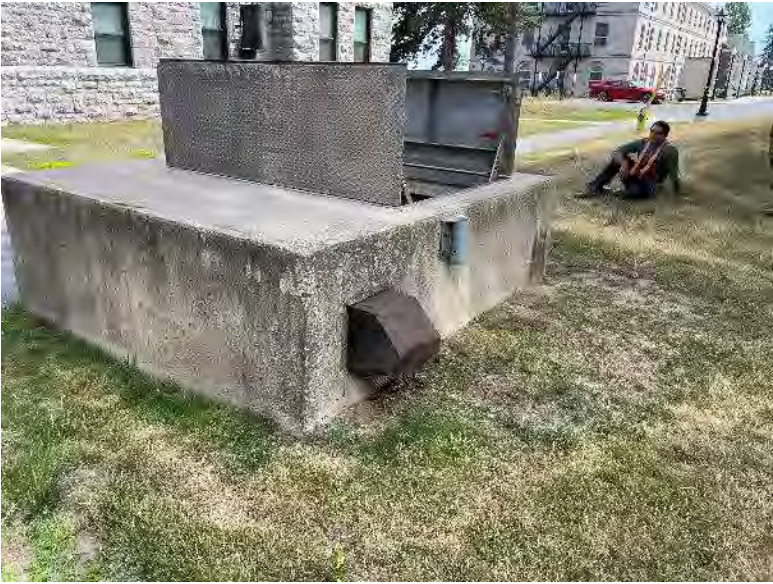
Description	Manhole 982: Harness bracket(s) mounted on exterior surface of manhole

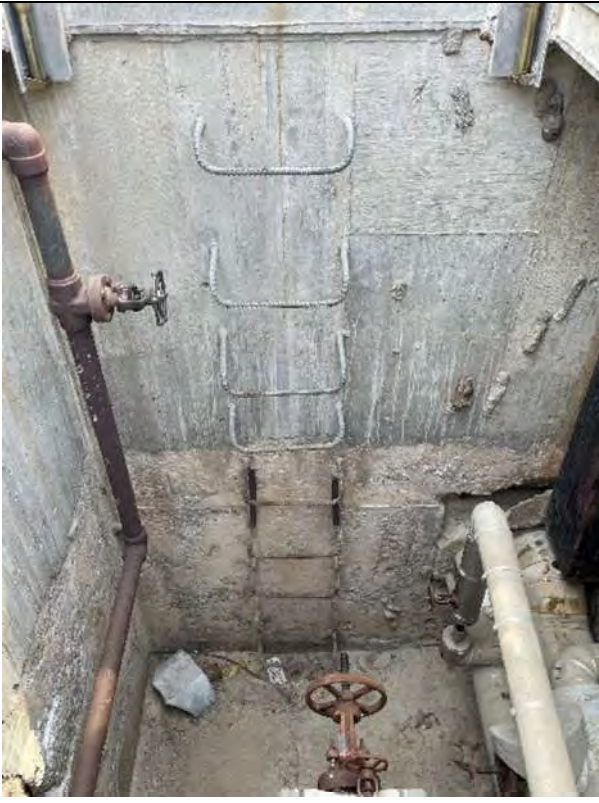
Photo	3

Description	Manhole 982: Ladder / Egress rungs
Photo	4

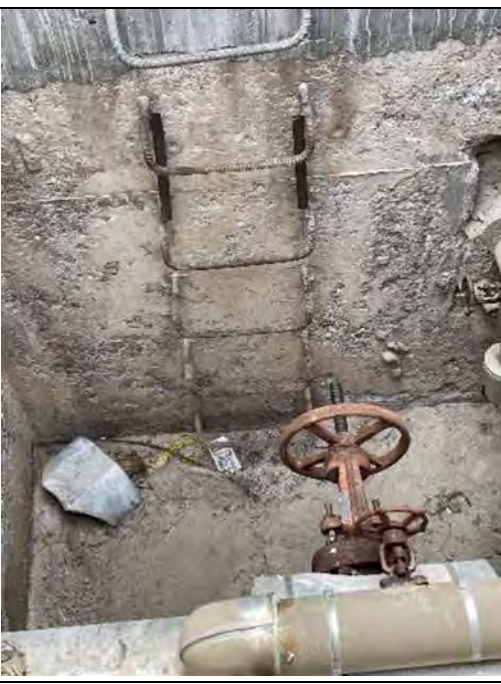
Description	Manhole 982: Ladder / Egress rungs (condition photo)

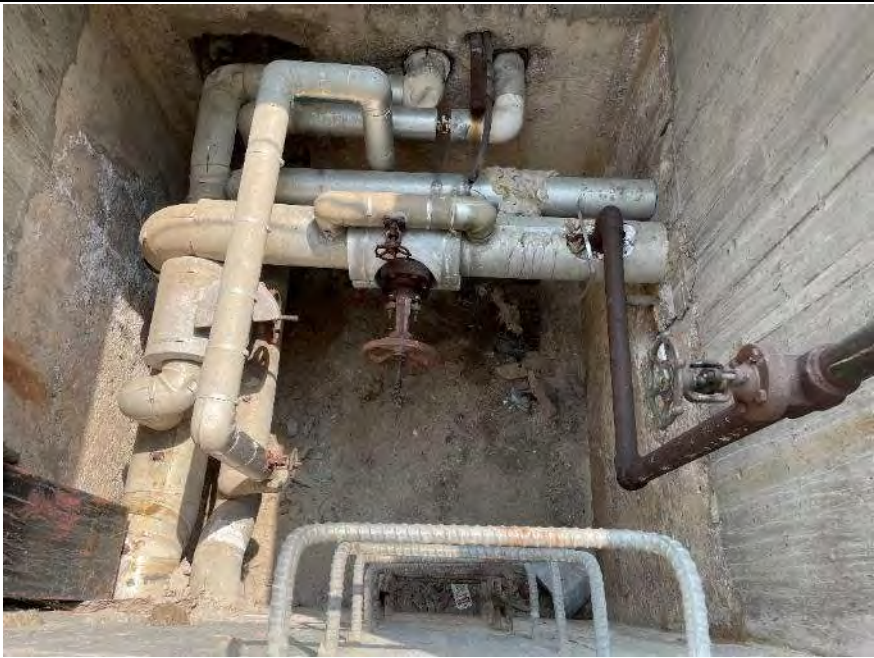
Photo	5

Description	Manhole 982: Full piping layout (Photo 1 of 2)
Photo	6

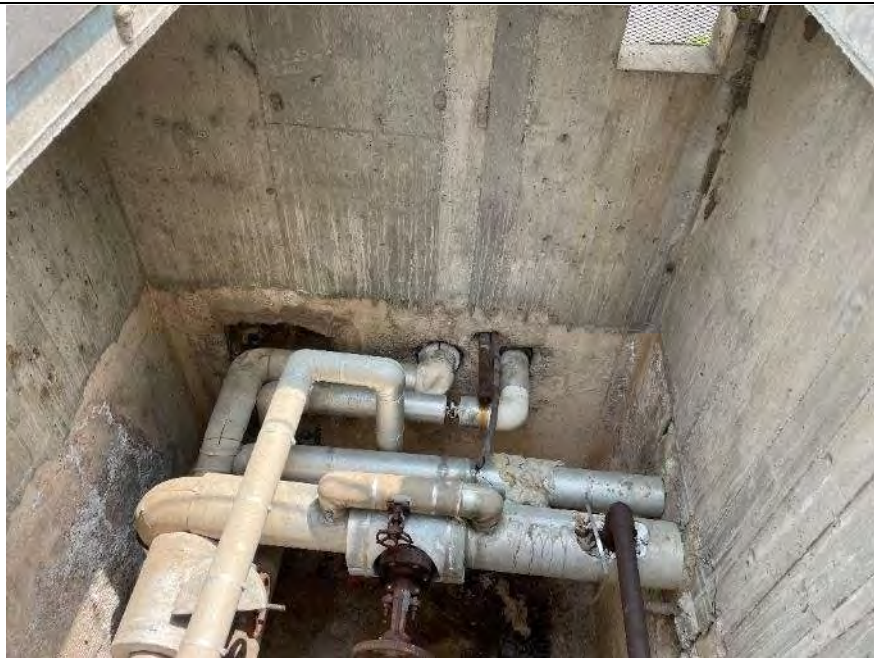
Description	Manhole 982: Full piping layout (Photo 2 of 2)

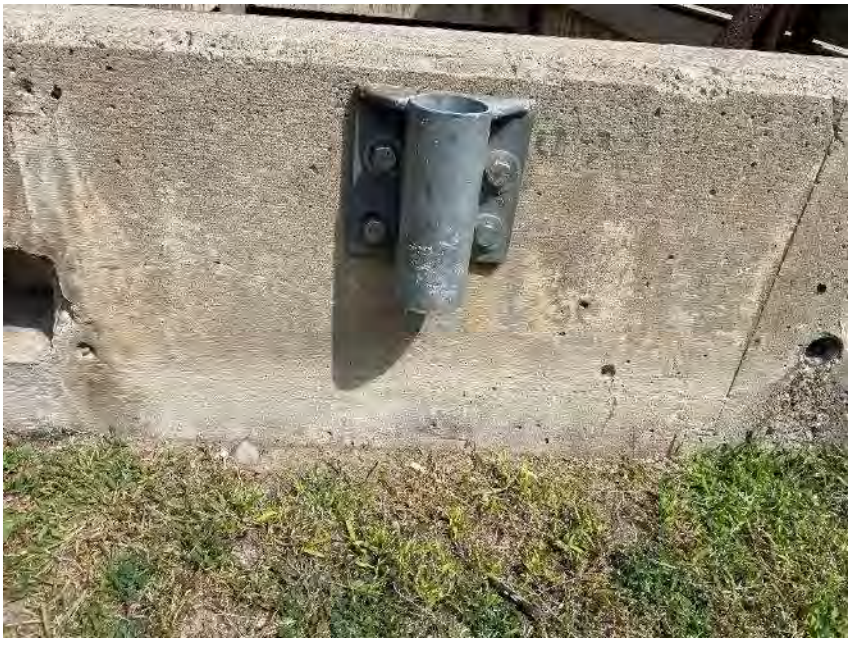
Photo	1

Description	Manhole 923: Harness bracket(s) mounted on exterior surface of manhole (condition photo)
Photo	2

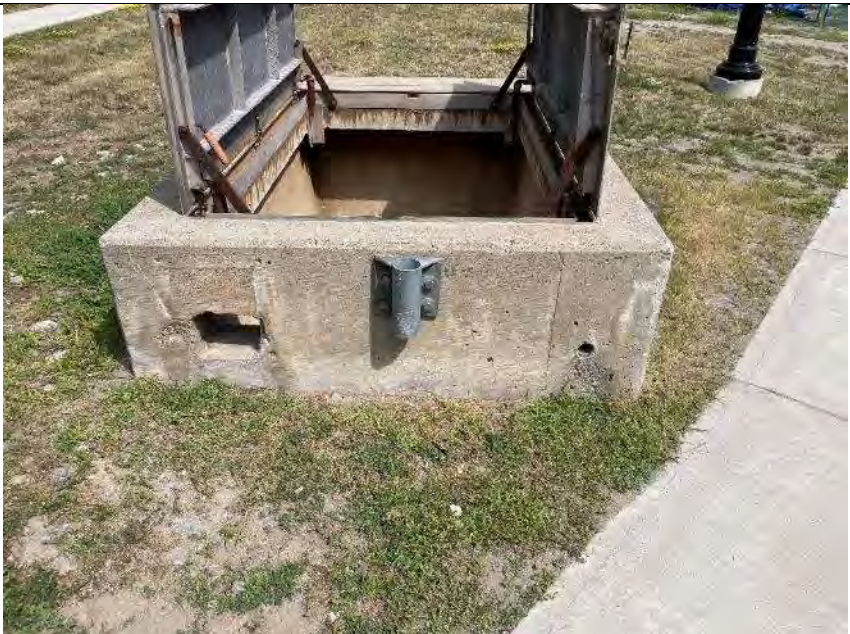
Description	Manhole 923: Harness bracket(s) mounted on exterior surface of manhole (orientation photo)

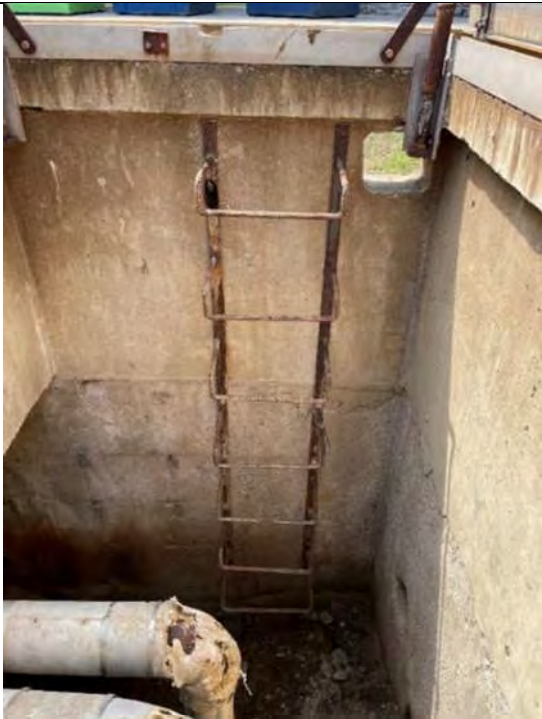
Photo	3

Description	Manhole 923: Ladder / Egress rungs	
Photo	4

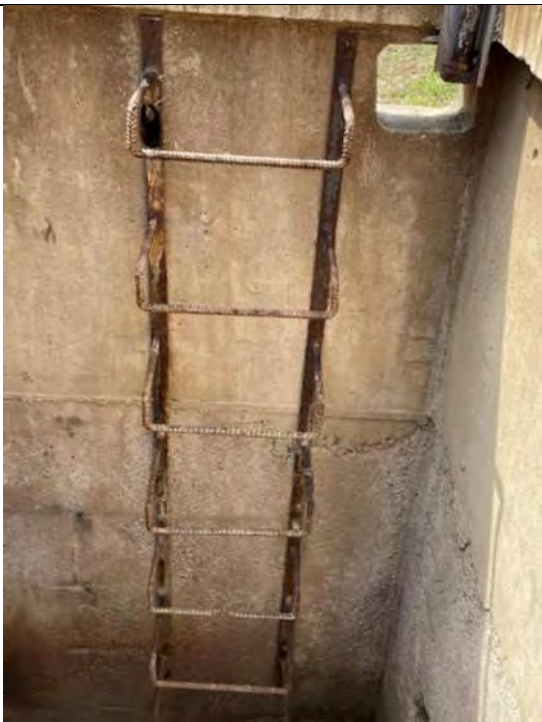
Description	Manhole 923: Ladder / Egress rungs (condition photo)
